# RESOLVING ERROR CODES FOLLOWING HUB REPLACEMENT

## Subaru Legacy and Outback

### Trouble Code after Hub Assembly Installation

- Subaru Legacy (2005-2014)
- Subaru Outback (2005-2014)

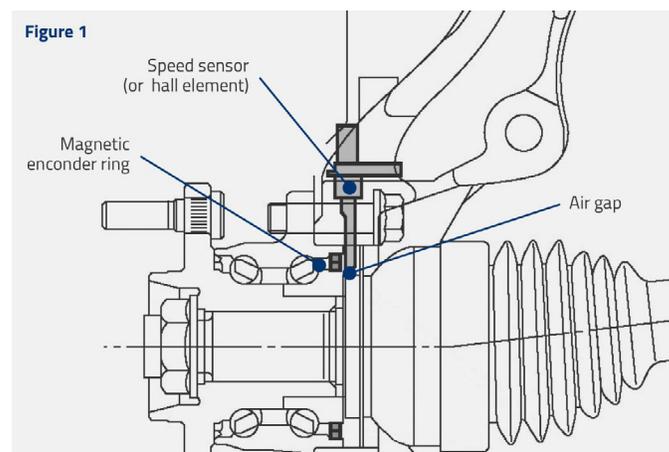
Check for rust—any rust present on the mounting area or on the backing plate can keep the bearing assembly from being fully seated (even when torqued down), creating an excessive "air gap" between the encoder and the sensor. It only takes a few extra thousandths of an inch to trigger the false error codes. (Fig. 1)

It is imperative that all the components involved in reassembly be thoroughly cleaned of rust, scale, grease, dirt and any other contaminants. Using a wire brush attachment, clean the knuckle face. Using an abrasive brush with a Dremel tool, clean the inside of the knuckle and backing plate of loose rust and scale.

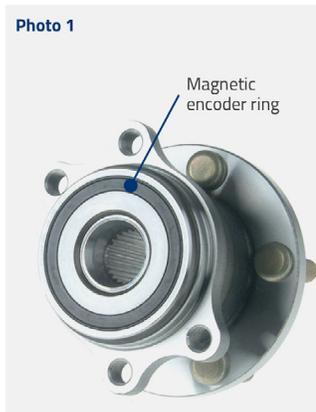
In addition, during re-assembly any rust present on the knuckle or backing plate might get dislodged and adhere to the magnetic encoder ring of the new hub assembly. Also, check for any dirt, grease or metal particles on the tip of the sensor. Any of these conditions will cause interference within the magnetic field and will result in the pulse being erratic or blocked altogether.

*Knuckle with hub removed*

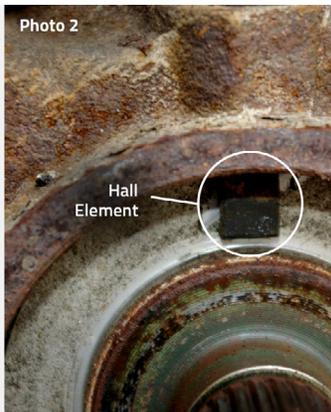
*Backing plate with old hub in place*

*Note: It's imperative to remove loose rust to prevent an excessive air gap.*
