4 GAS ANALYSER TEST : CORRECT GAS VALUES FOR VEHICLES EQUIPPED WITH CATALYTIC CONVERTER SYSTEMS

DIAGNOSIS OF THE CATALYTIC CONVERTER

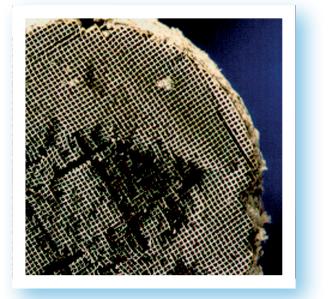
DAMAGED MONOLITH DUE TO INCORRECT LEVEL OF **BACKPRESSURE WITHIN THE EXHAUST SYSTEM**

The use of non-homologated parts and/or the presence of cracks in the catalytic converter or exhaust system can lead to variations in system backpressure, creating continuous leakage of unburned fuel (HC) that will reduce the service life of the converter. This situation generates small fusions of the monolith surface which in most cases leads to the detachment of the monolith inside the catalytic converter housing where, because it collides with the metallic walls

of the catalytic converter housing, it eventually breaks, forming the typical shape of "spherical biscuit" that we usually see on opening a noisy catalytic converter.

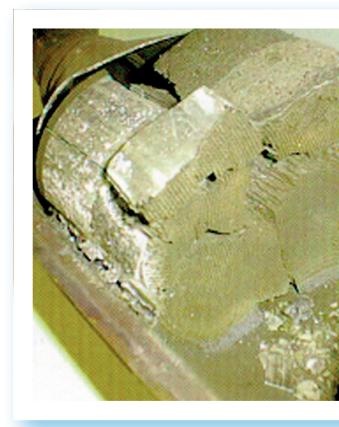
FRACTURED MONOLITH DUE TO EXTERNAL IMPACTS OR DENTS OF MORE THAN 1MM DEEP ON THE OUTER HOUSING

Any impact capable of causing a dent or scratch of more than 1mm deep in the catalytic converter housing has sufficient energy to fracture the ceramic monolith that is situated inside, leaving it useless, and possibly causing serious damage to the engine and the rest of the emission control system components (diesel particulate filter, selective reduction catalytic converters, other silencers, etc.) because of the sudden increase in the levels of back-pressure inside the system.

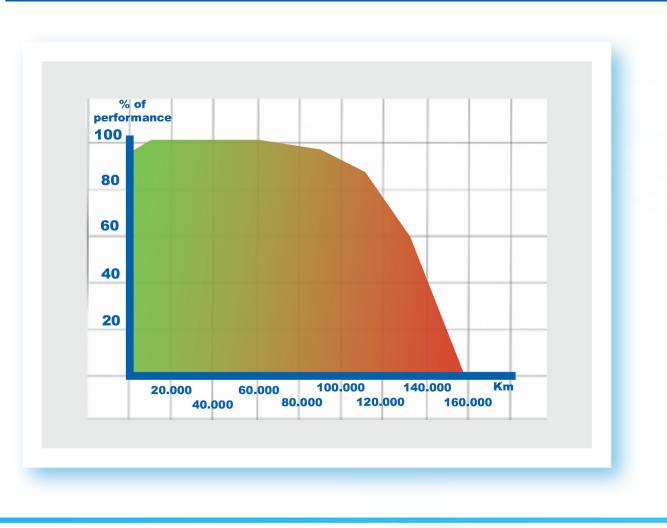
FAILURE OF THE CATALYTIC CONVERTER DUE TO NATURAL WEAR OF THE UNIT

- Throughout the vehicle's life, due to usage, a fine layer of combustion residues is deposited on the surface of the precious metals, reducing the capacity of the catalytic converter to transform the harmful gasses before they are released into the atmosphere. When this happens, the catalytic converter must be replaced by a new unit.
- It is considered that the useful life of a catalytic converter is of some 100.000 to 140.000 km. The lifetime of the catalytic converter will depend on various factors such as the quality of the fuel being used, the way in which the vehicle is driven, the frequency and quality of the maintenance of the vehicle, etc.
- Walker[®] recommend to check the emission control system every 20.000 km or once a year in order to determine the condition of the catalytic converter and all the elements linked to this important system.

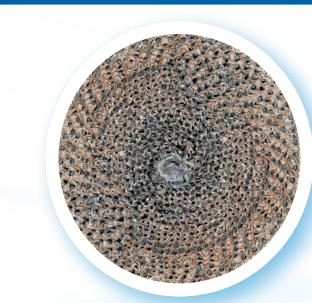
DAMAGED MONOLITH DUE TO CHEMICAL POISONING

Monolith completely clogged by phosphorous deposits. This is the result of failures that cause the engine to burn more than 1 litre of oil per 1.000 km (eg. piston rings wear problems).

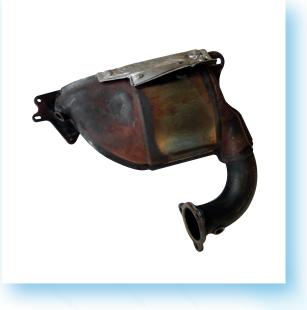
Chemical pollution of the monolith due to the use of lead, generally coming from leaded gasoline or anti-detonant additives not designed for use in catalysed vehicles.

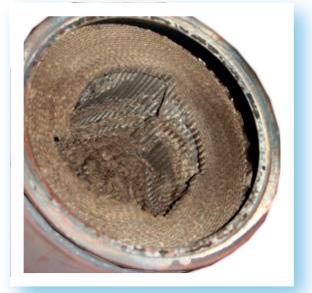
Monolith partially clogged due to the use of rich air to fuel mixtures. Dirty air filters, intake problems and air leaks before the lambda sensors are often the cause of this failure.
