DIAGNOSIS OF EXHAUST SYSTEM

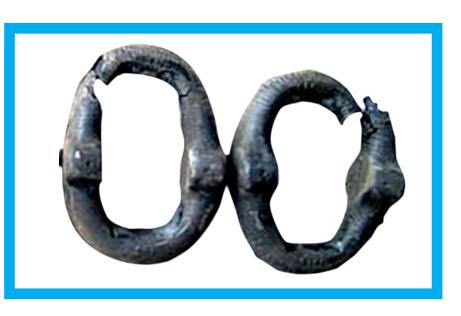
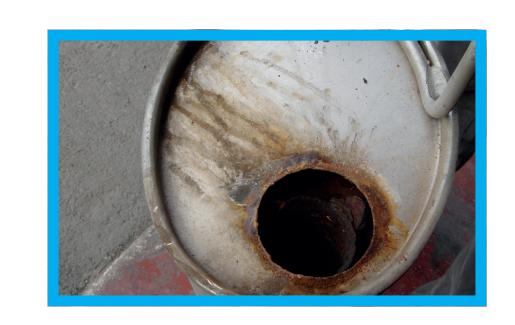
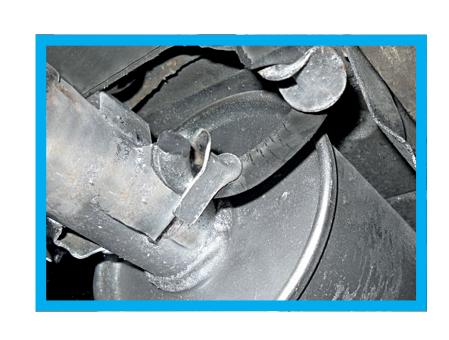
PIPE & RUBBER HANGER DEFECTS

Worn-out or broken rubber hangers produce a perfectly round cut, around the welded joint where the pipe connects to the silencer housing. This is a common failure where the silencer has been replaced using the old rubber hangers.

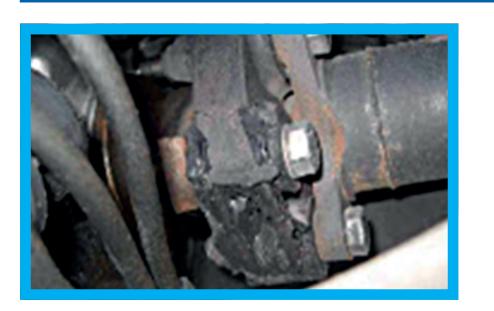
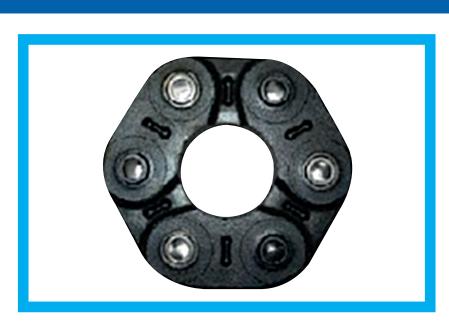
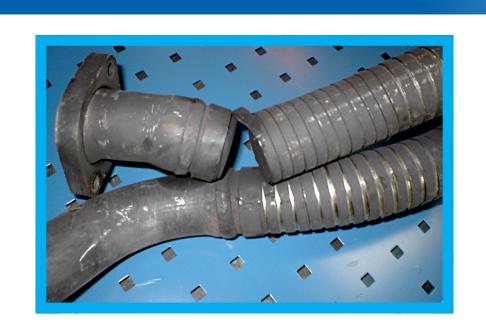
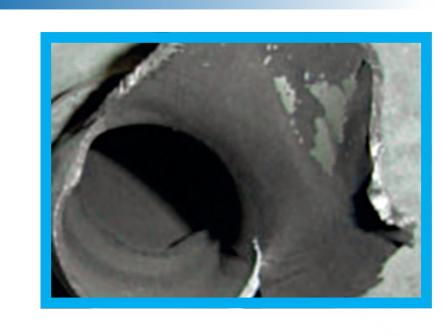
WORN ENGINE MOUNTINGS & FLEXIBLE DRIVE SHAFT JOINT DEFECTS

Worn-out or broken engine mountings or flexible drive shaft joints produce a typical irregularly shaped fracture which destroys the pipe a few centimetres behind the connection to the silencer.

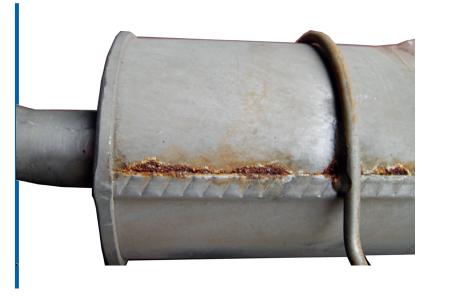
Hermetic seam of the housing is rusted: this only becomes a problem when it generates an air leakage.

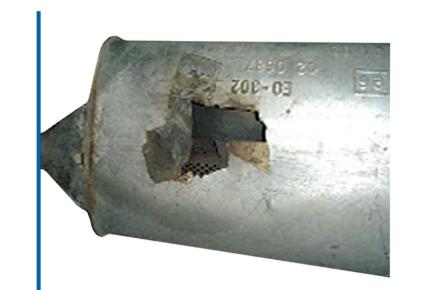
Perforated exhaust housing. This failure is common in mono-layer silencers due to the accumulation of water inside.

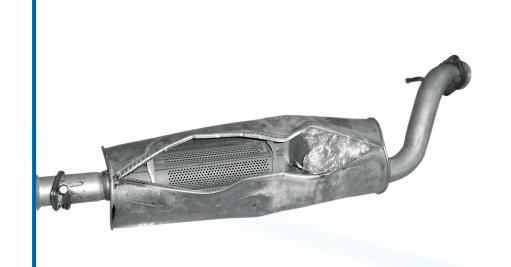
Silencer housing has exploded due to condensation of unburned fuel (HC) inside the silencer.
