Abex[®]

AB803

AIR DISC BRAKE PADS
PLAQUETTES DE FREIN
À DISQUE PNEUMATIQUE
PASTILLAS DE FRENOS
DE DISCO NEUMÁTICOS

Abex® Air Disc Brake Pads

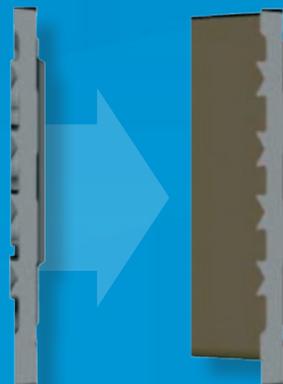
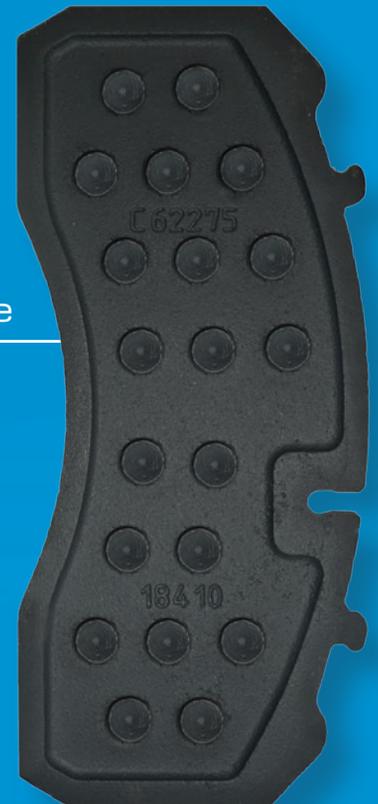
OE Material(s)
Thermal Underlayer

Green Coating —
for Rapid Bedding-In

V-Groove Design

Cast Iron Back Plate

New patented cast iron backplate technology for safer and more efficient braking performance

- Utilizes the latest advances in proprietary back plate cast iron technology
- Lighter than standard backplates
- Secure bond between pad material and backplate with less risk of corrosion

Secure Bond with Backing Plate

Abex air brake pads have patented cast iron backplates and an integrally molded V-groove design which greatly improves heat dispersal and eliminates excessive material stress. When you need a brake that stops faster with enhanced durability for long lasting performance — Abex is the ideal choice for all of your commercial vehicle braking needs.

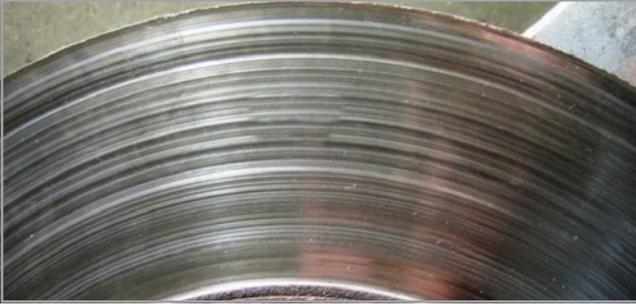
APPEARANCE Rotor featuring scored surface.
CAUSE Pads fitted with friction material too harsh for the rotor or new pads assembled on excessively worn out rotors.
EFFECT Reduction in braking performance and possible imbalance on the affected axle during braking.
REMEDY

- Replace the pads.
- Check rotor condition and minimum thickness. If necessary, replace the rotor.
- Check for the quality of the spare parts used.

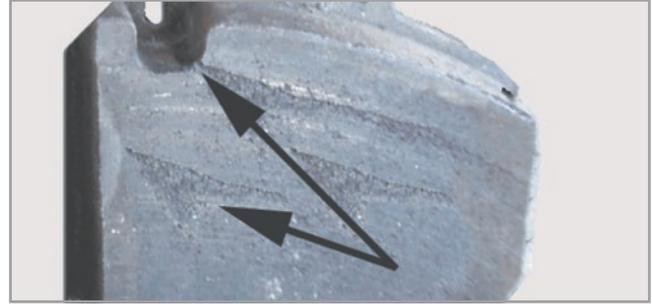
APPEARANCE Excessively worn out rotors and pads.
CAUSE Possible contamination of the friction material by sand, mud or earth or incomplete return of the caliper gear.
EFFECT Excessive wear of one or more brake pads, resulting in damage where the pad has not been fitted with a wear indicator.
REMEDY

- Replace the pads.
- Check rotor condition and minimum thickness.
- If necessary, replace both rotors on the axle.

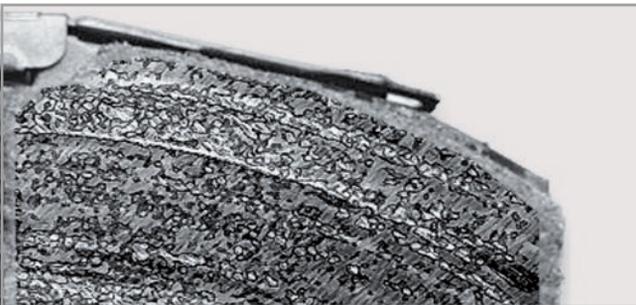
APPEARANCE Contaminated pad friction material.
CAUSE Contamination by an oily substance or solvent.
EFFECT Reduction in braking performance and possible imbalance during braking.
REMEDY

- Replace the pads.
- Check the rotors on the axle.
- Identify any fluid leaks from the hubs or other nearby components.

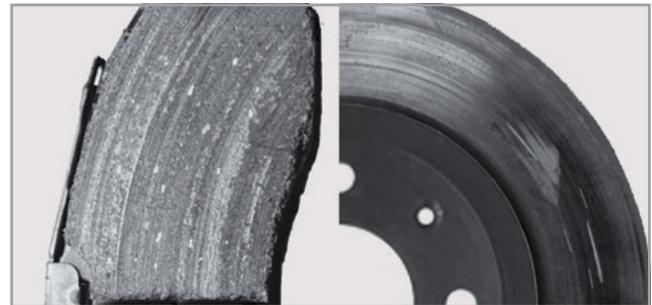
APPEARANCE Friction includes metal pick-up.
CAUSE High temperature generated between brake pad and rotor in wet conditions.
EFFECT Wear of the affected brake rotor with typical metal rubbing noise during braking.
REMEDY

- Replace the pads.
- Check rotor condition and minimum thickness.
- If necessary, replace both rotors on the axle.

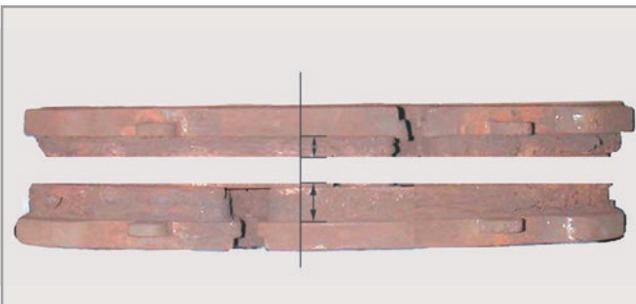
APPEARANCE Uneven brake pad wear.
CAUSE One of the calipers has become stuck or does not return correctly to the rest position.
EFFECT Reduction in braking performance and possible imbalance on the involved axle, during braking.
REMEDY

- Replace the pads.
- Brake calipers should be checked.

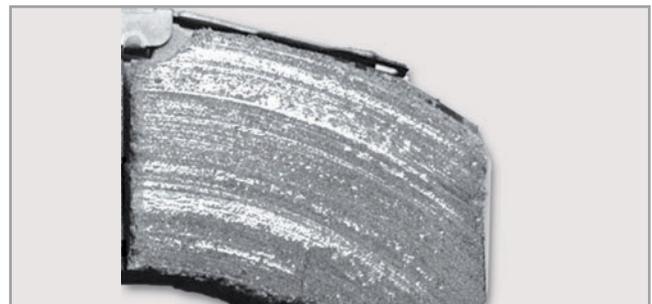
APPEARANCE Glazed pad friction material.
CAUSE Very low duty applied on the brakes, i.e. brake applications with low speed and low pressure.
EFFECT Reduction in braking performance and typical noise (squeal) while braking.
REMEDY

- If glazing is not too heavy can try to recondition the surface by some mileage of medium/hard brake duty, otherwise replace the pads.
- Check the rotor condition and minimum thickness.

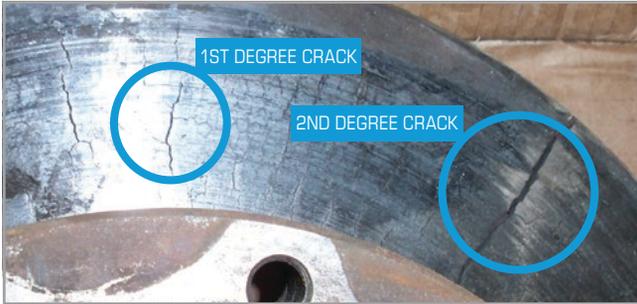
APPEARANCE Rotor surface features 1st and 2nd degree crack.

CAUSE Too intensive use of brakes due to the track features or to the carried load.

EFFECT Possible unexpected rotor mechanical collapse, particularly with 2nd degree crack.

- Immediate replacement of brake rotors and pads, particularly with 2nd degree crack, when one of the cracks is travelling from OD to ID.
- Brake calipers should be checked.

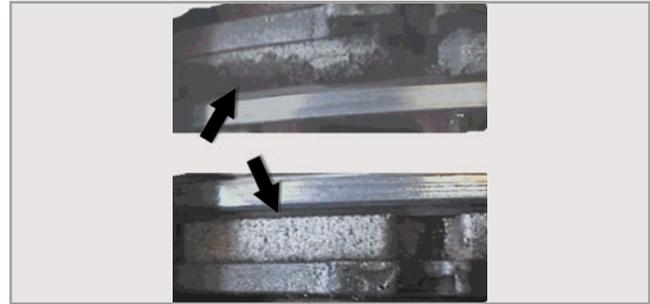
APPEARANCE Damaged edges to the friction material (edge-crumbling).

CAUSE Brake pad has become stuck in the caliper. The parts used do not comply with the correct sizes and specifications.

EFFECT Early pad deterioration and uneven rotor wear.

- Replace the pads.
- Check for correct caliper operation.
- Check rotor condition and minimum thickness.
- If necessary, replace both rotors on the axle.

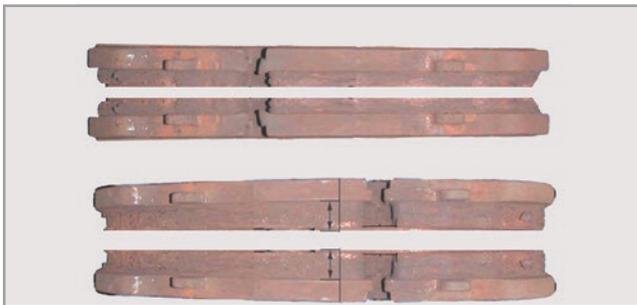
APPEARANCE Pads on the same axle featuring uneven wear.

CAUSE Incorrect return of one caliper on the same axle.

EFFECT If the axle involved is the directional one, this fault may result in vehicle instability during brake release.

- Replace the pads.
- Check for the proper caliper operation.
- Check rotor condition and minimum thickness.
- If necessary, replace both rotors on the axle.

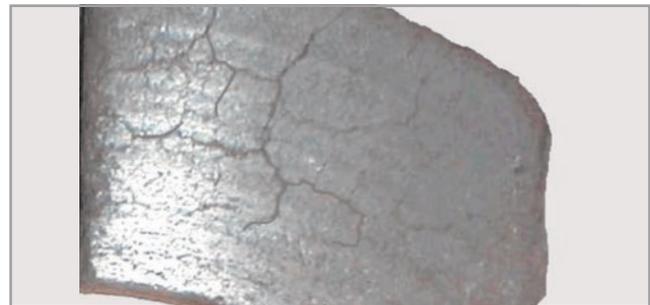
APPEARANCE Pad with surface cracks.

CAUSE Excessive load or high friction material temperature.

EFFECT Possible detachment of friction material resulting in a reduction in braking performance.

- Replace the pads.
- Check for correct caliper operation.
- Check rotor condition and minimum thickness.
- If necessary, replace both rotors on the axle.

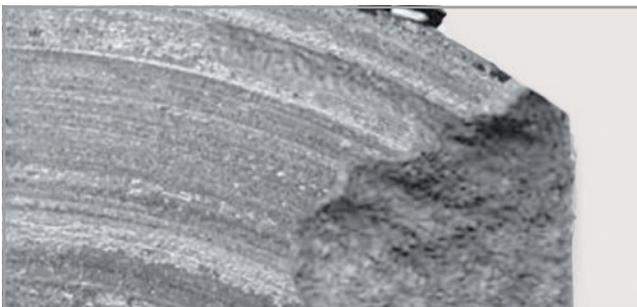
APPEARANCE Detached friction material.

CAUSE Possible excessive load or heavy braking, along with the choice of unsuitable parts.

EFFECT Reduction in braking performance and typical noise (squeal) while braking.

- Replace the pads.
- Check the rotor condition and minimum thickness.
- Despite having a wear indicator, it is necessary to check the pad condition during normal brake inspection and/or every six months.

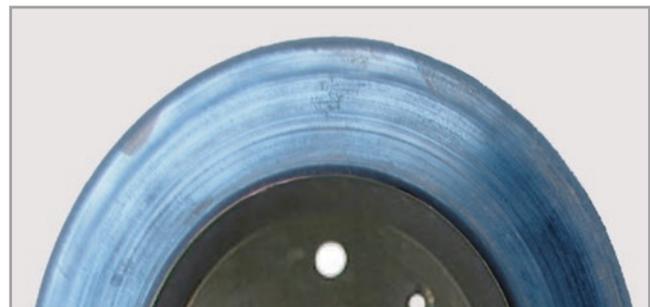
APPEARANCE Blue stripes on the rotor indicating a physical change due to overheating.

CAUSE Intensive use of brakes for prolonged braking or improper downhill braking.

EFFECT Brake rotor overheating which may result in contact surface distortion and cracks.

- Immediate replacement of brake rotors and pads.
- During the first 150 miles after replacement, sharp braking should be avoided in order to allow for the correct bedding-in of the newly fitted components.

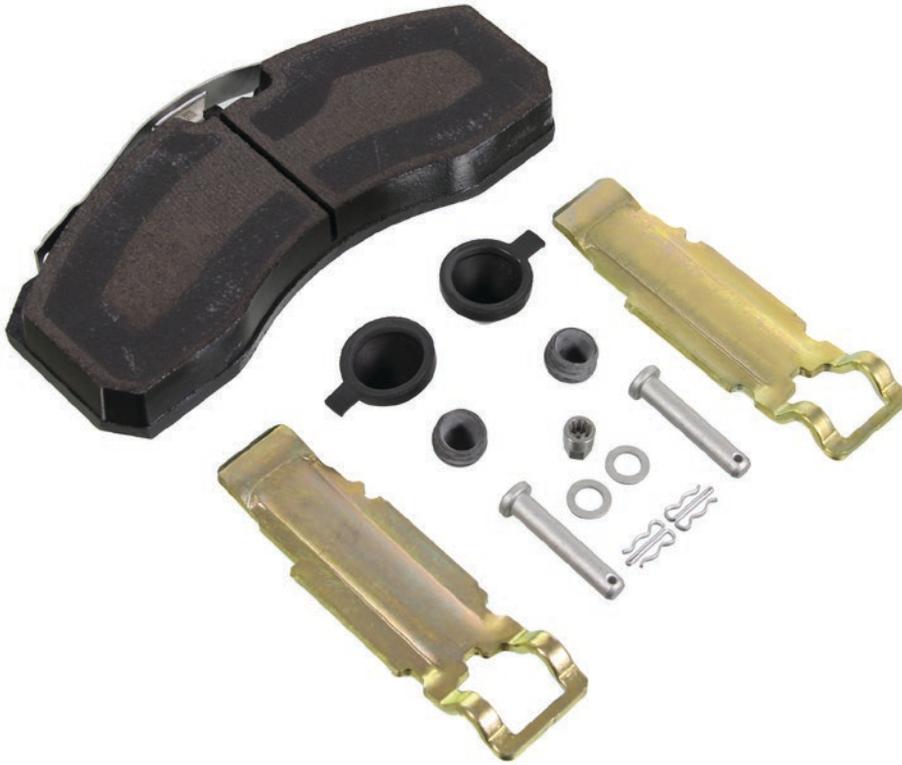
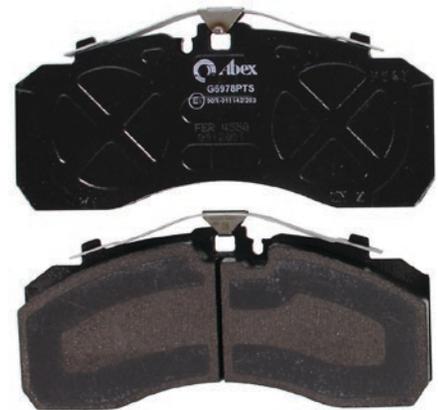
Brake Pad:	ADB1203AFE
Type:	Knorr SB/SN7
Applications:	Over-the-Road Coach
X-ref:	5013257 1138162F
FMSI:	8323-D1203
WVA:	29179
Material:	4550
Comments:	Includes OE style Hardware Kit

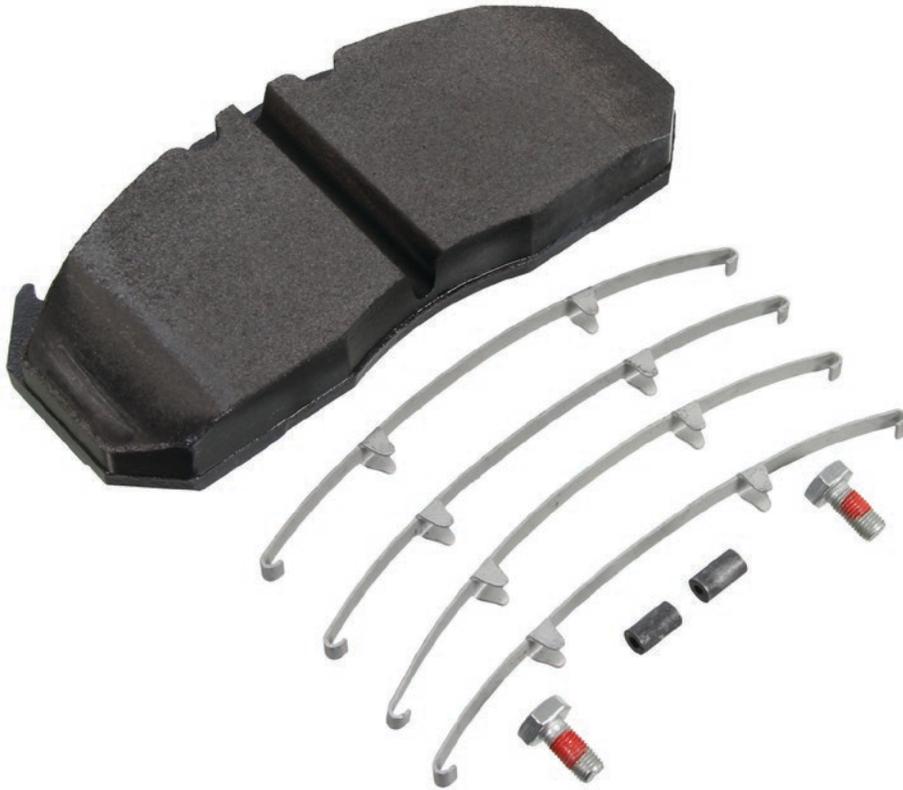
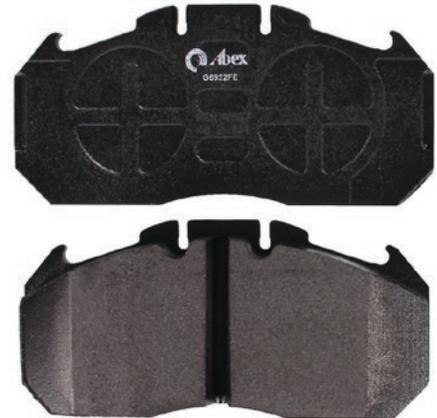
Brake Pad:	ADB1310FE
Type:	Meritor D-Elsa 2
Applications:	City Bus
X-ref:	MDP5097 N508206052
FMSI:	8425-D1310
WVA:	29156
Material:	4567
Comments:	Includes OE style Hardware Kit

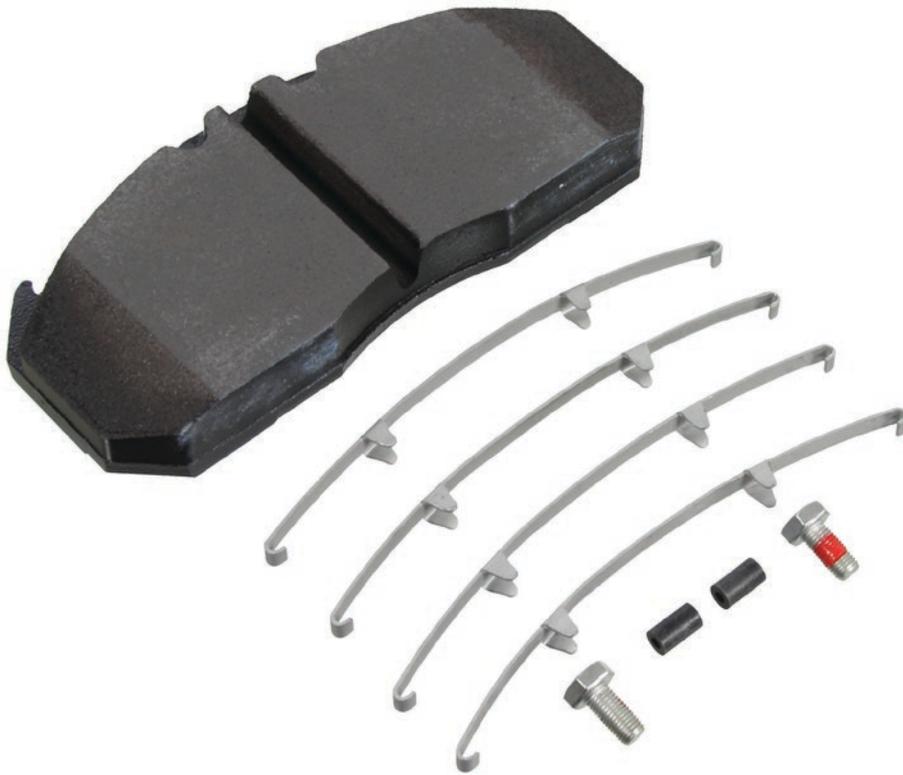
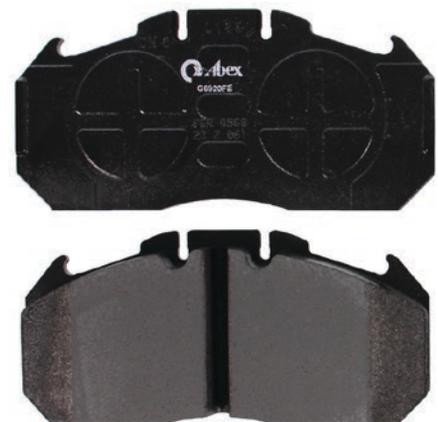
Brake Pad:	ADB1310AFE
Type:	Meritor D-Elsa 2
Applications:	Over-the-Road Coach
X-ref:	MDP5060 N508206051
FMSI:	8425-D1310
WVA:	29156
Material:	4568
Comments:	Includes OE style Hardware Kit

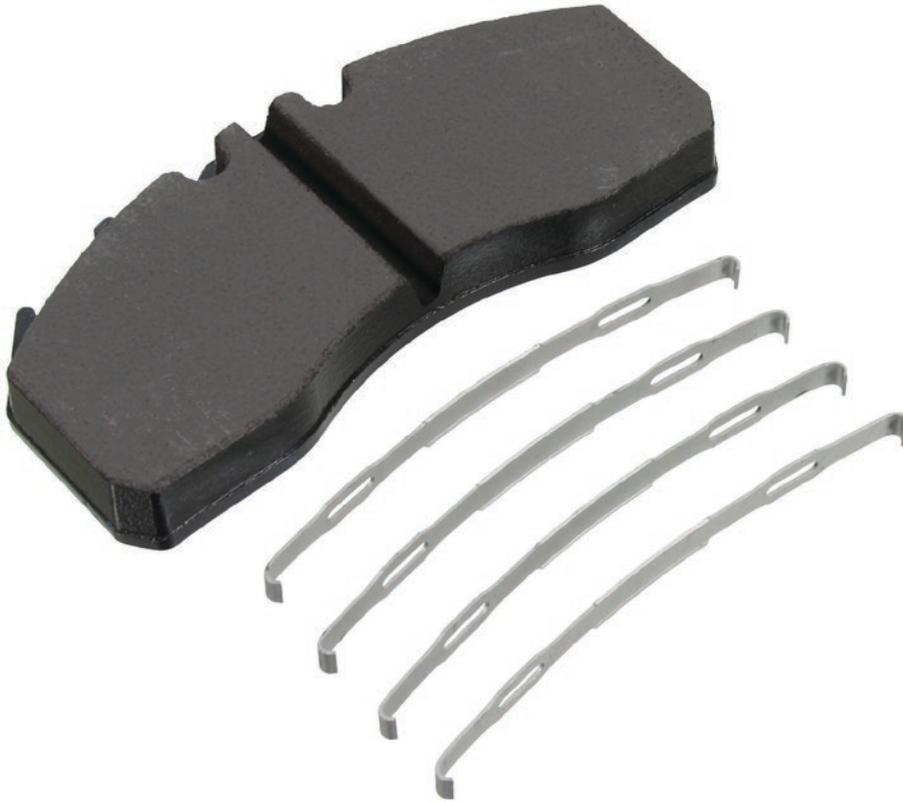
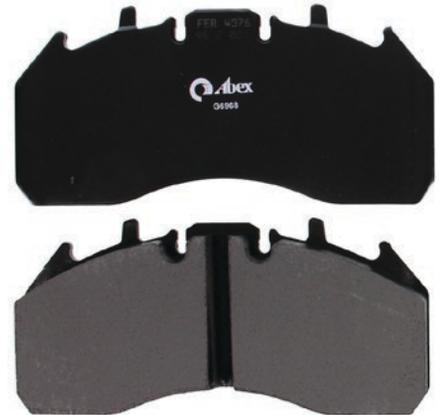
Brake Pad:	ADB1311
Type:	Meritor EX225H2
Applications:	Bus and Coach
X-ref:	Meritor KIT2252H2CD MCI #04-01-1113
FMSI:	8426-D1311
WVA:	29187
Material:	4576
Comments:	Includes OE style Hardware Kit

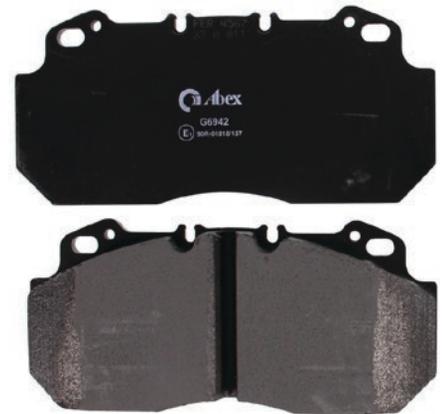
Brake Pad:	ADB1312
Type:	Meritor D-Lisa
Applications:	City Bus
X-ref:	68932068NZP
FMSI:	8427-D1312
WVA:	29090
Material:	4567
Comments:	Includes OE style Hardware Kit

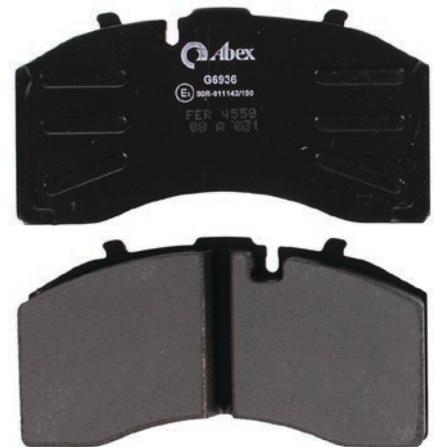
Brake Pad:	ADB1369
Type:	Bendix® ADB22XTM™ Knorr SK7
Applications:	SAF Tractor-Trailer
X-ref:	802078, K070796
FMSI:	8479-D1369
WVA:	29158
Material:	4550
Comments:	Includes OE style Hardware Kit

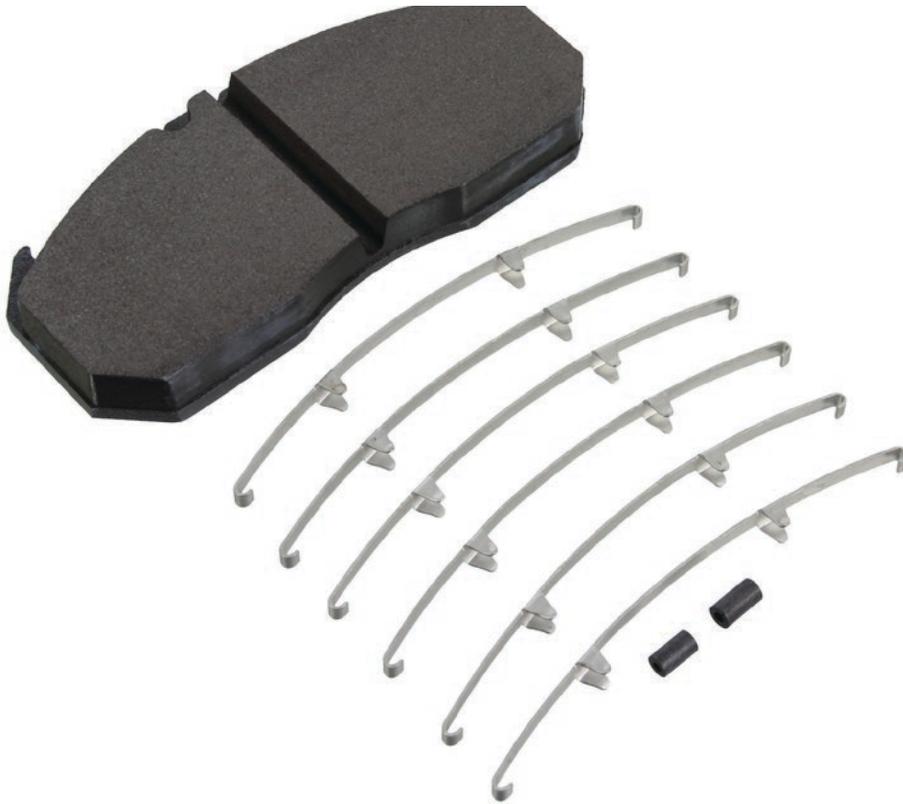
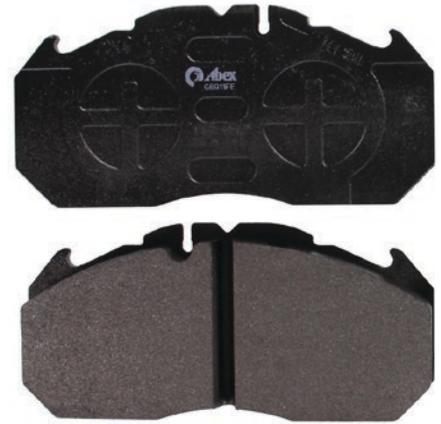
Brake Pad:	ADB1407FE
Type:	Meritor D3/D-Elsa1
Applications:	City Bus
X-ref:	MDP5065
FMSI:	8515-D1407
WVA:	29210
Material:	4567
Comments:	Includes OE style Hardware Kit

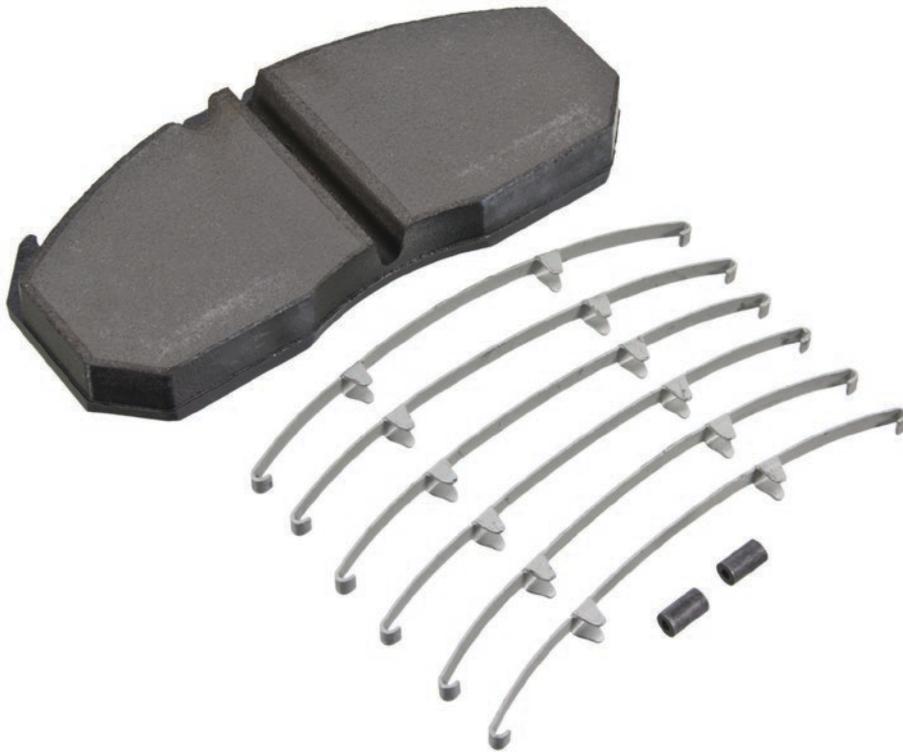
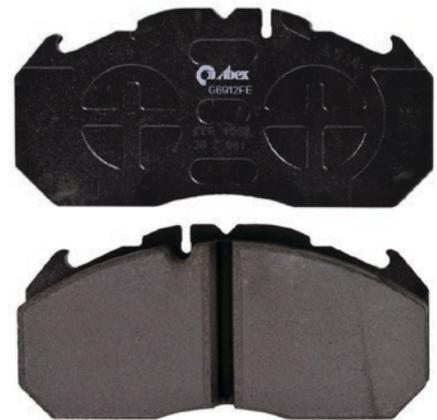
Brake Pad:	ADB1407AFE
Type:	Meritor D3/D-Elsa1
Applications:	Over-the-Road-Coach
X-ref:	MDP5038
FMSI:	8515-D1407
WVA:	29210
Material:	4568
Comments:	Includes OE style Hardware Kit

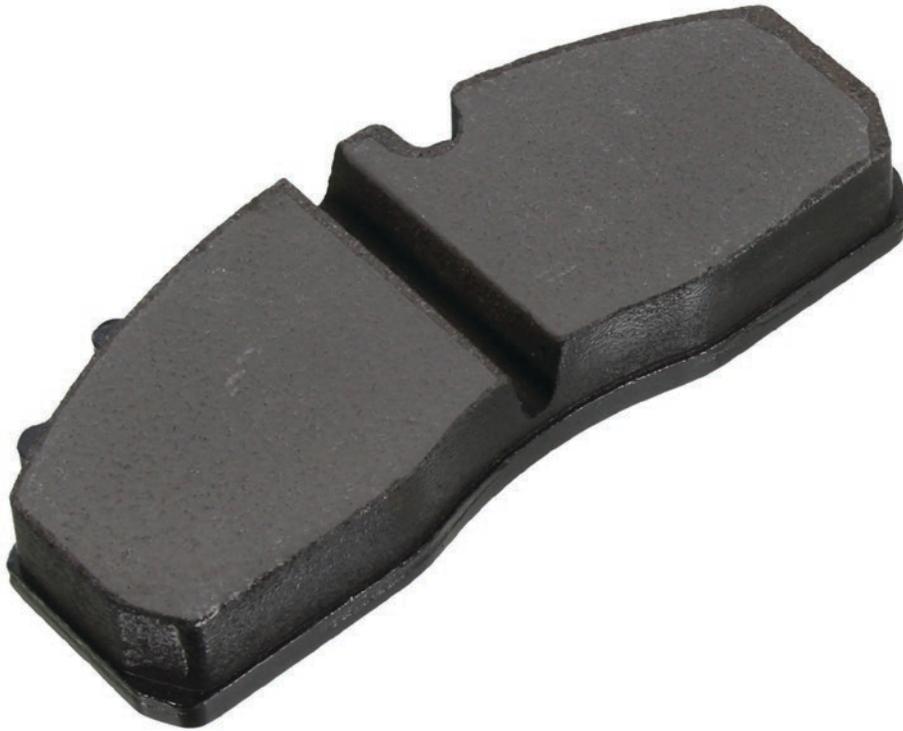
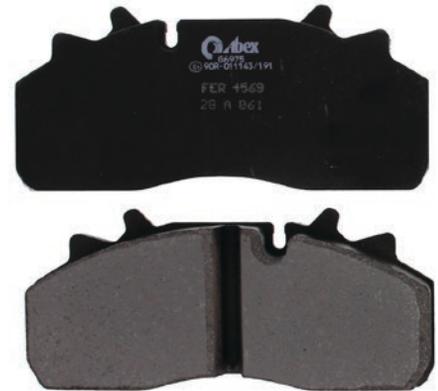
Brake Pad:	ADB1438
Type:	Wabco Pan19-1
X-ref:	12999737VT
FMSI:	8556-D1438
WVA:	29159
Material:	4569
Comments:	No Kit

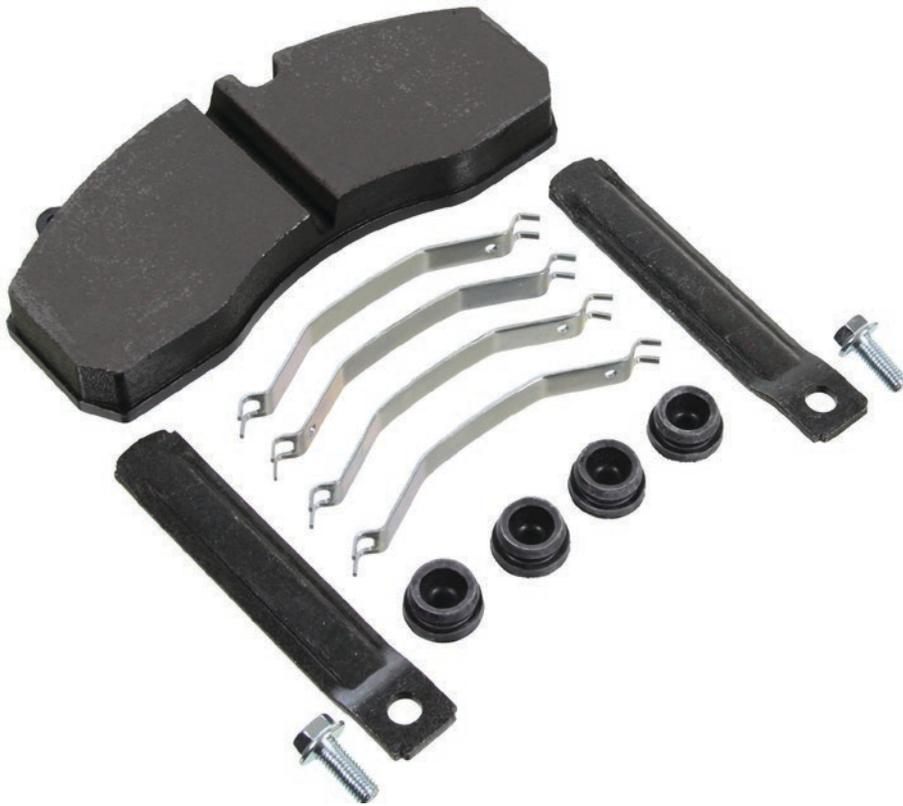
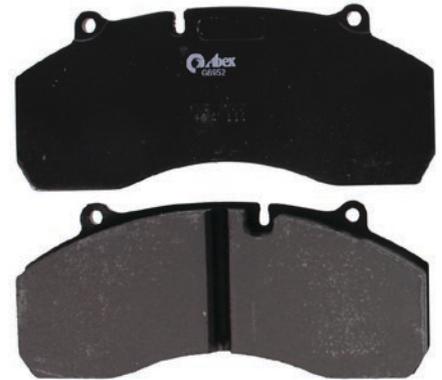
Brake Pad:	ADB1441
Type:	Bendix® ESD-225™
X-ref:	976003
FMSI:	8577-D1441
WVA:	29120
Material:	4550
Comments:	Includes OE style Hardware Kit

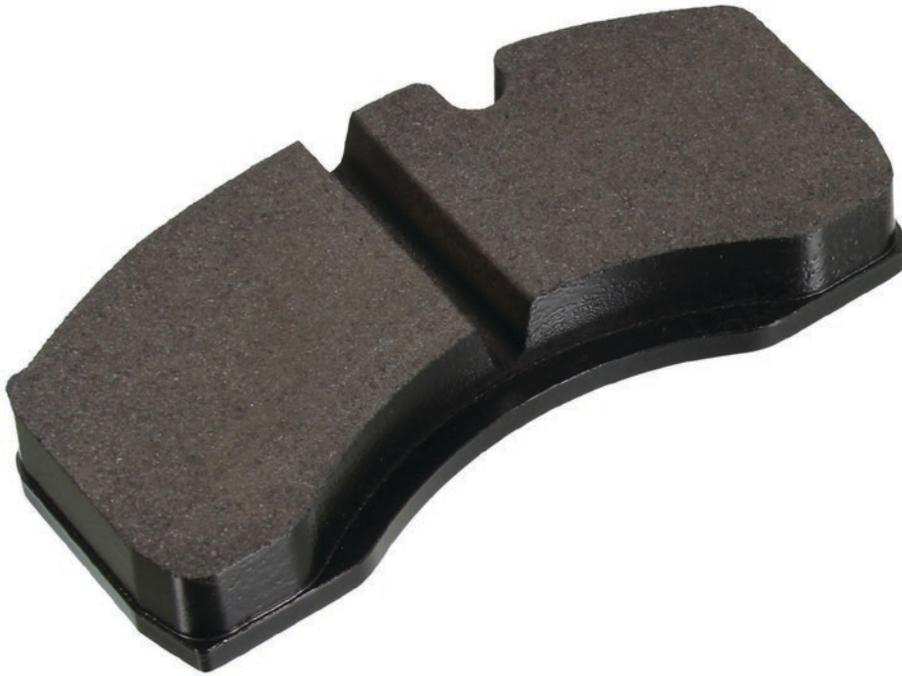
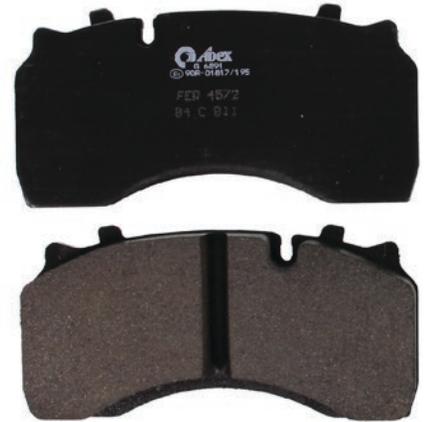
Brake Pad:	ADB1517
Type:	Wabco Pan19-2
X-ref:	12999747VT
FMSI:	8726-D1517
WVA:	29141
Material:	4572
Comments:	No Kit

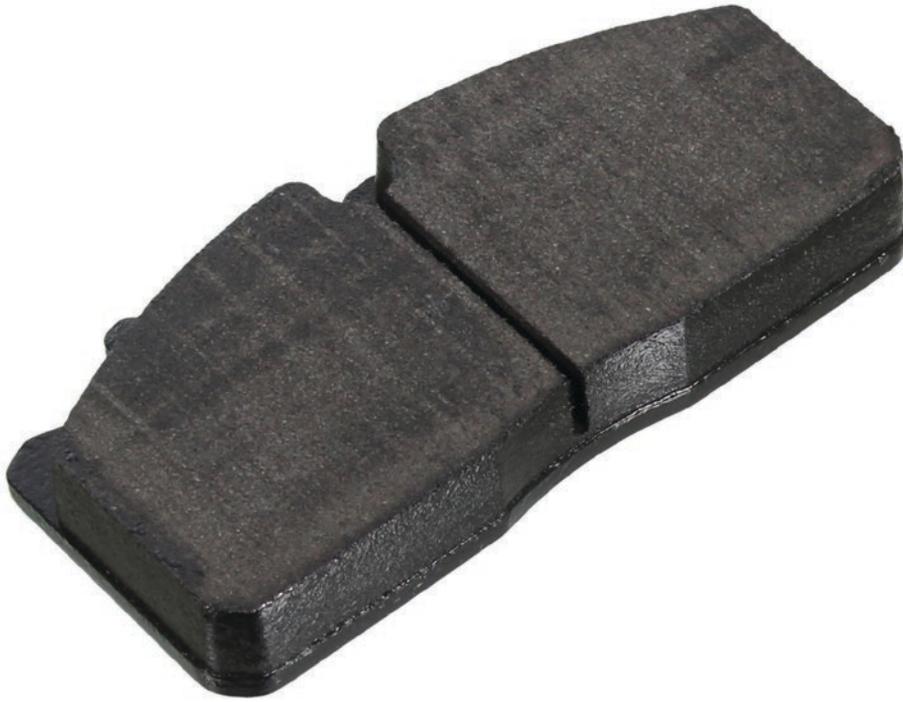
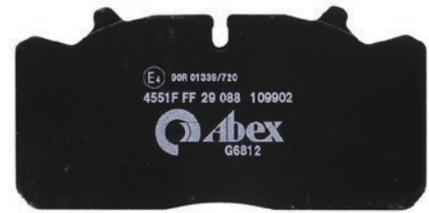
Brake Pad:	ADB1518
Type:	Wabco Pan17
X-ref:	12999703VT
FMSI:	8727-D518
WVA:	29088
Material:	4551
Comments:	No Kit

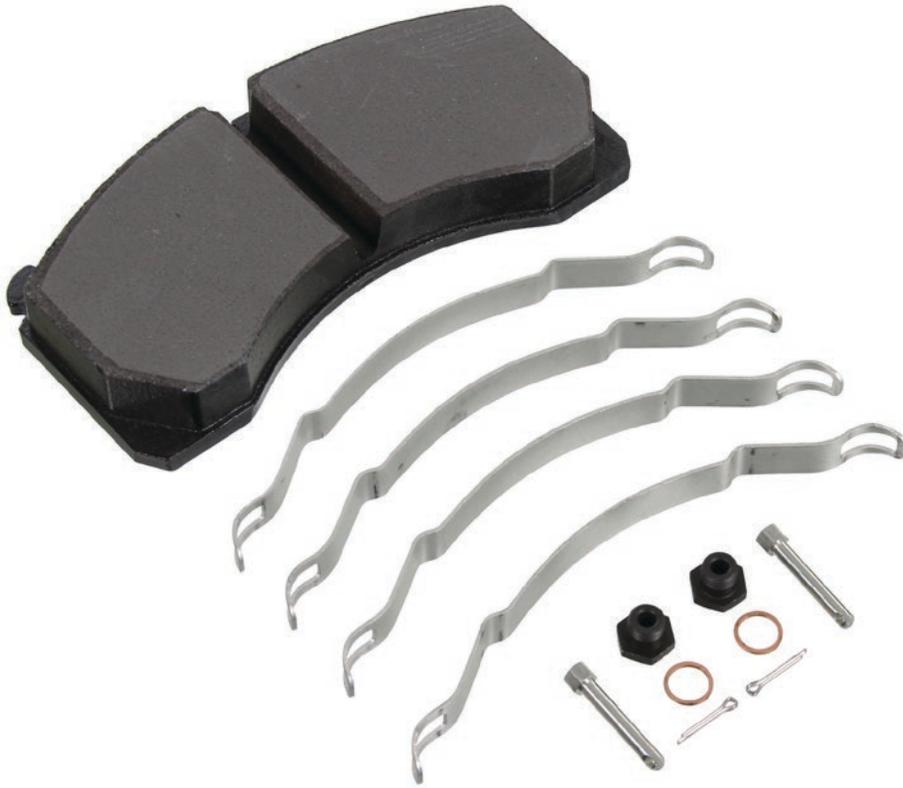
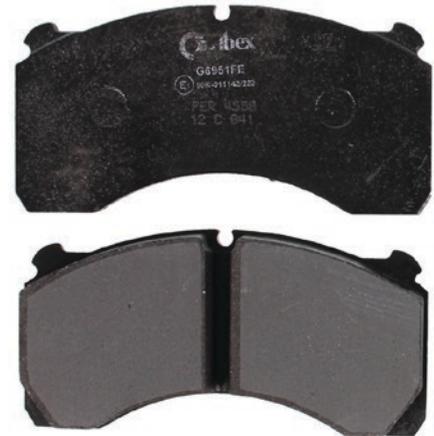
Brake Pad:	ADB1525FE
Type:	Meritor DX195
X-ref:	KIT 195020
FMSI:	8733-D1525
WVA:	29155
Material:	4550
Comments:	Includes OE style Hardware Kit

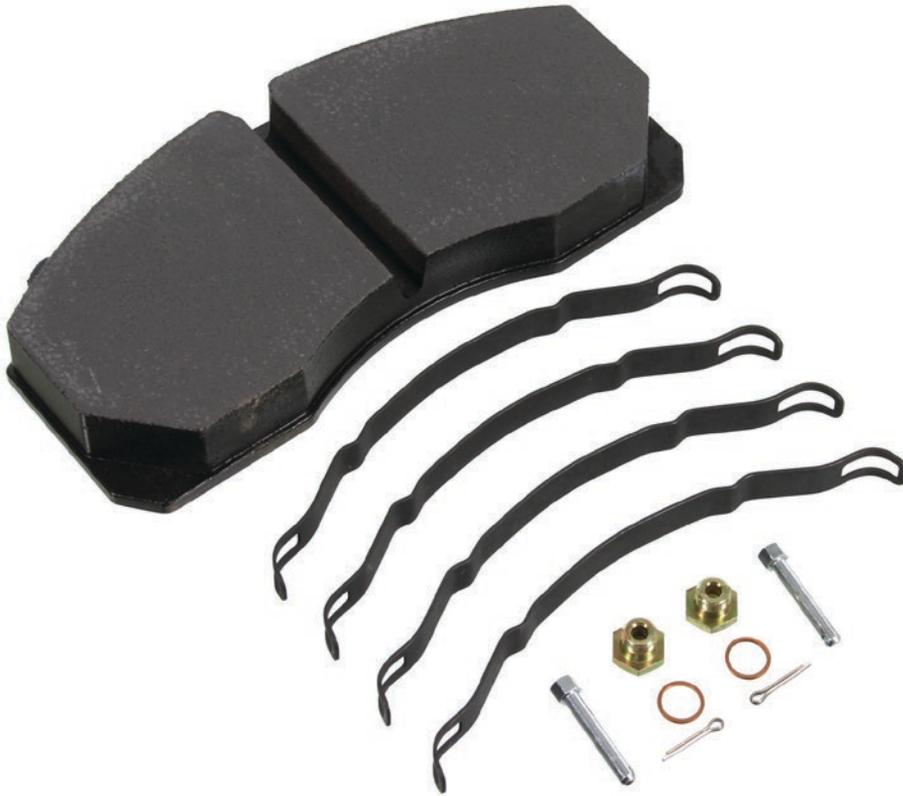
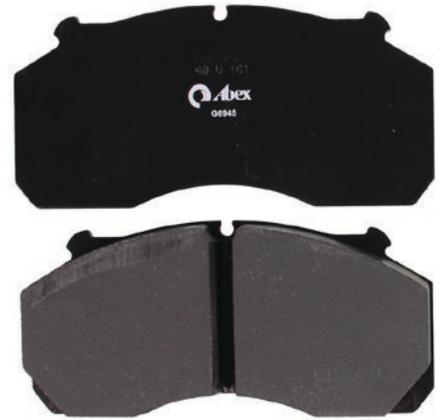
Brake Pad:	ADB1526
Type:	Meritor DX225
X-ref:	KIT225020
FMSI:	8734-D1526
WVA:	29150
Material:	4567
Comments:	Includes OE style Hardware Kit

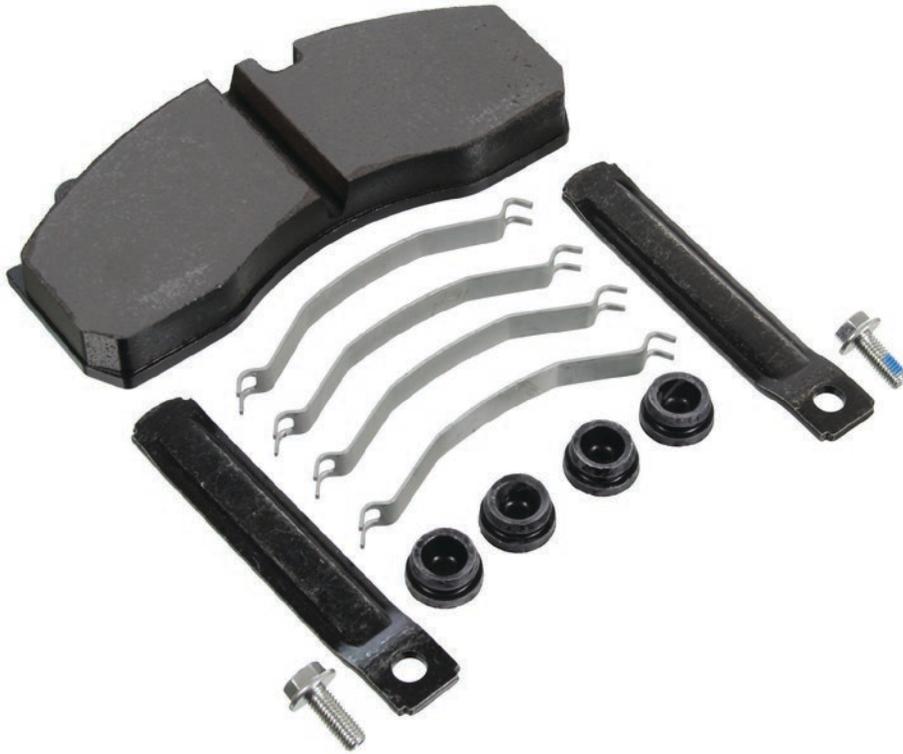
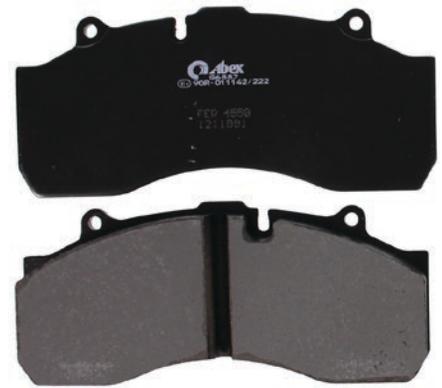
Brake Pad:	ADB1527
Type:	Haldex ModulX® DB22
X-ref:	790-22008
FMSI:	8735-D1527
WVA:	29143
Material:	4550
Comments:	Includes OE style Hardware Kit
