6.0L POWER STROKE® HEAD GASKET

FEL-PRO® INTRODUCES LONG-AWAITED SOLUTION TO CHRONIC SEALING ISSUES FACING ENGINE PROFESSIONALS

A LOOK INSIDE THE 6.0L POWER STROKE®

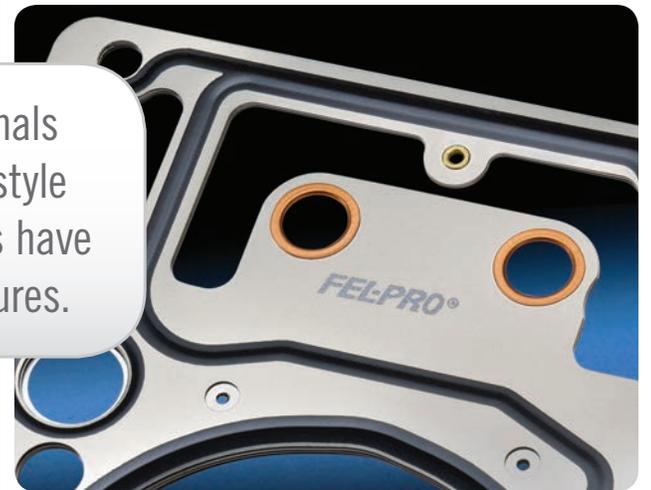
2003-2010 Ford 6.0L V8 Diesel Turbo (Power Stroke)

- OE technology: Conventional multi-layer steel
- Fel-Pro solution: **PermaTorque® MLS**
- #26374PT 18mm dowel pin applications
- #26375PT 20mm dowel pin applications

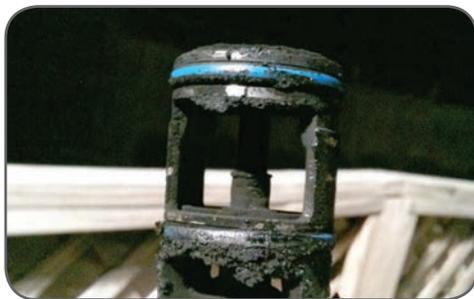
Figure 1

Carbon contamination of the EGR valves (see Fig. 1) is one of the most common issues encountered on this engine. Once a valve is clogged, it can stick in

the open position, causing a noticeable drop in power. The same contamination issue can affect the EGR cooler, leading to more serious consequences. These coolers are also prone to leakage, introducing coolant into the exhaust stream.

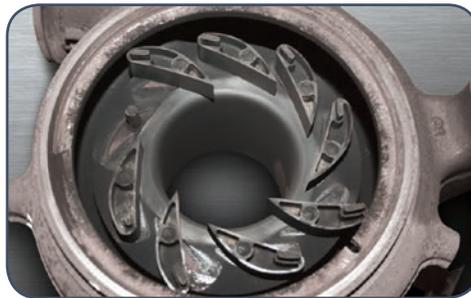
Figure 2

As noted above, this engine provides excellent turbo response...when everything is operating correctly. This is made possible by a “variable geometry turbo” design utilizing vanes (Fig. 2) to continually adjust the volume of the turbo housing. Keep these vanes clean of soot, either by removing and cleaning the turbo unit or, better yet, by periodically running the engine at full throttle.

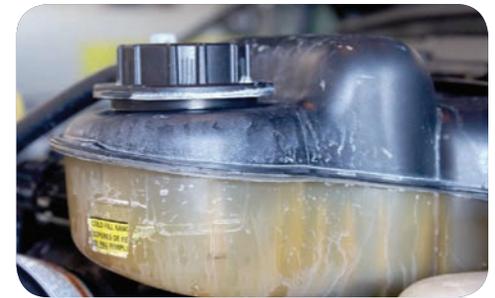
Figure 4

Yes, the obvious source of a coolant leak is a blown head gasket, which, in this engine, has happened with great frequency for many owners over the past decade. But don't overlook the easy causes – one is a cracked degas bottle (Fig. 4).

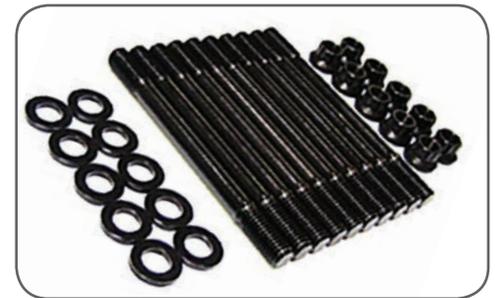
Figure 5

New Fel-Pro PermaTorque MLS head gaskets and T-T-Y head bolts (important: never, ever re-use T-T-Y bolts) will provide excellent reliability in this engine. In cases when power-adding modifications have been made, consider swapping out conventional head bolts with a high-quality aftermarket stud kit (Fig. 5). This will significantly increase clamp load and sealing strength in extreme conditions.
