THE PROBLEM SOLVER®

TIE ROD END

2006-2010 DODGE RAM 1500

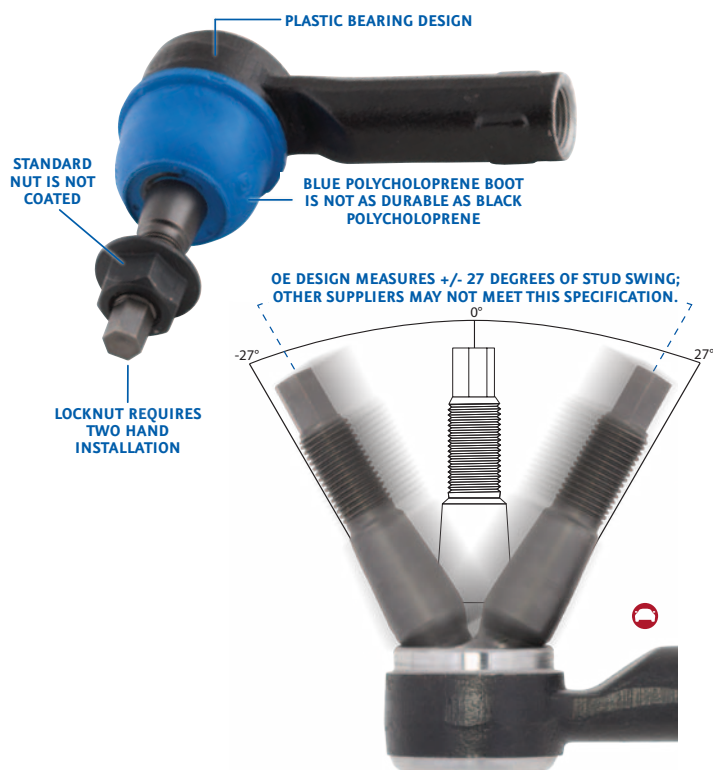
Tie Rod End Failure

The OE part has specific design requirements pertaining to stud swing and stud coating that some suppliers do not adhere to. The OE knuckle is aluminum and requires a coated stud to prevent galvanic corrosion. The OE stud also incorporates +/- 27 degrees of swing.

In addition, plastic bearing and lack of preload on OE and other suppliers' parts leads to accelerated wear and subsequent failure when these applications undergo commercial and fleet use. Plus the use of a locking nut by other suppliers makes installation more difficult, as it may turn the stud during tightening.

MOOG® Problem Solver® ES80574 Tie Rod End

The MOOG® Problem Solver® ES80574 Tie Rod End is designed to exceed OE specifications, and to allow for ease of installation and longer life in fleet and commercial applications.

- Features exclusive gusher bearing technology for durability and long life.
- Greaseable design flushes contamination and keeps part lubricated.
- MOOG patented domed cover plate and Belleville washer ensure proper preload and consistent socket torque for the life of the part.
- Full-ball metal stud features zinc dichromate coating to prevent galvanic corrosion when mated to the aluminum knuckle.
- Stud swing exceeds OE specification, preventing stud/housing impact (and subsequent damage) while maintaining stud pull out strength.
- Castle nut and wrench flats make installation and alignment easy.
