**AB803**

**AIR DISC BRAKE PADS  
PLAQUETTES DE FREIN  
À DISQUE PNEUMATIQUE  
PASTILLAS DE FRENOS  
DE DISCO NEUMÁTICOS**

# Abex® Air Disc Brake Pads

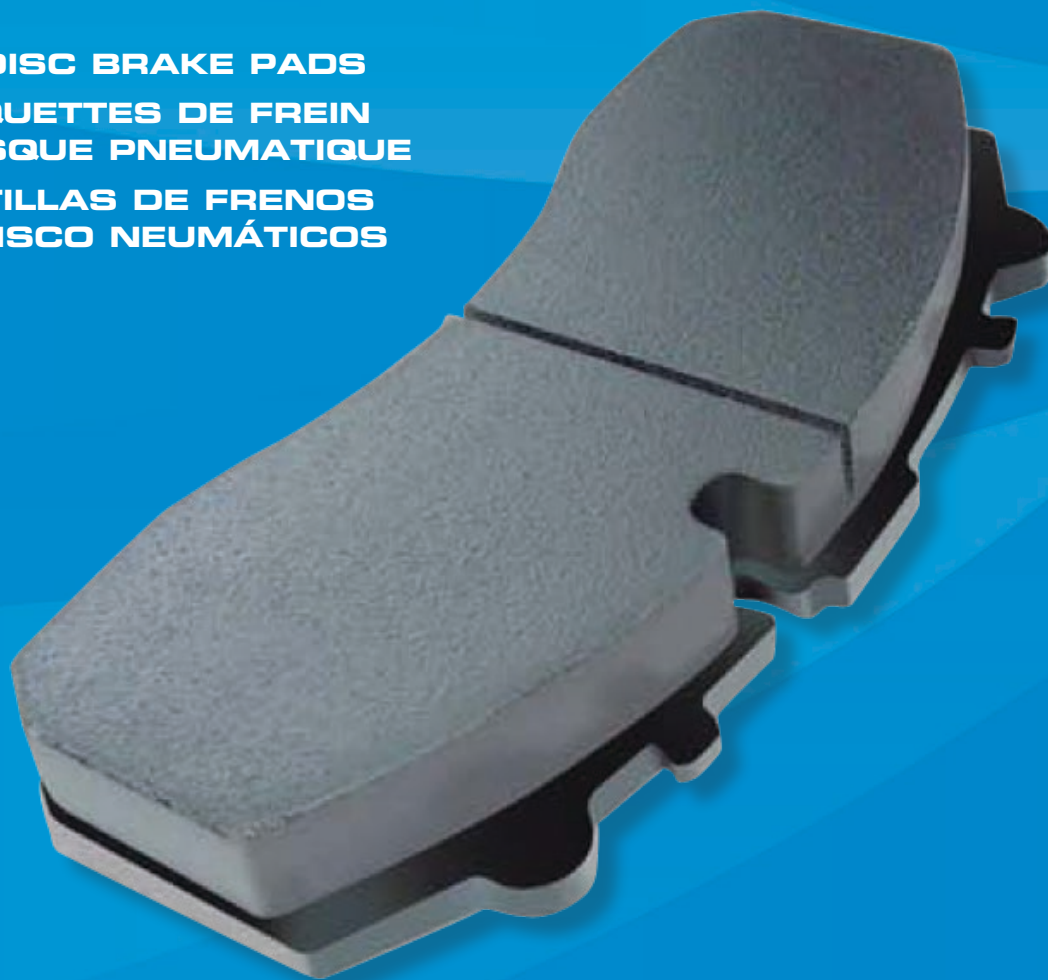
Abex air brake pads have patented cast iron backplates and an integrally molded V-groove design which greatly improves heat dispersal and eliminates excessive material stress. When you need a brake that stops faster with enhanced durability for long lasting performance — Abex is the ideal choice for all of your commercial vehicle braking needs.

OE Material(s)  
Thermal Underlayer

Green Coating —  
for Rapid Bedding-In

V-Groove Design

Cast Iron Back Plate

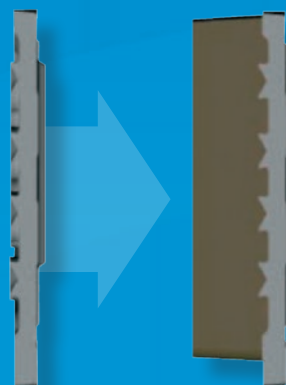
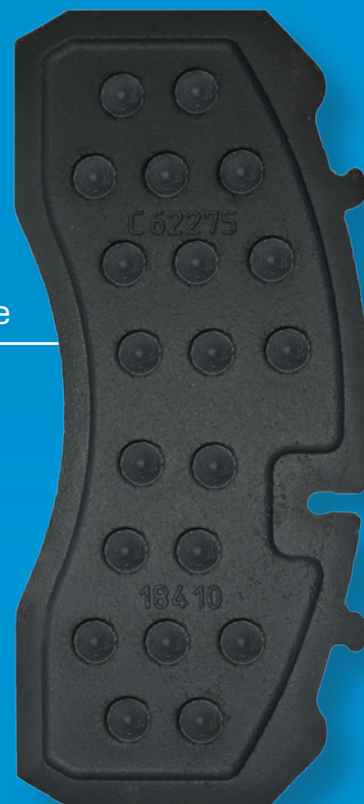
New patented cast iron backplate technology for safer and more efficient braking performance

- Utilizes the latest advances in proprietary back plate cast iron technology
- Lighter than standard backplates
- Secure bond between pad material and backplate with less risk of corrosion

Secure Bond with Backing Plate

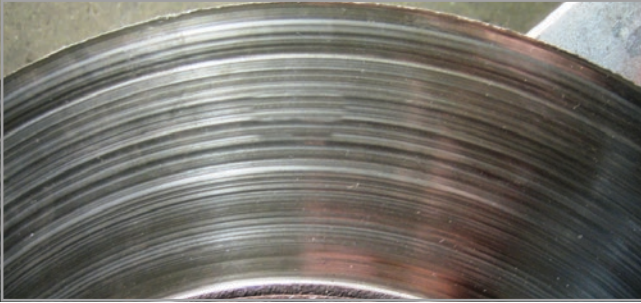
**APPEARANCE** Rotor featuring scored surface.

**CAUSE** Pads fitted with friction material too harsh for the rotor or new pads assembled on excessively worn out rotors.

**EFFECT** Reduction in braking performance and possible imbalance on the affected axle during braking.

- Replace the pads.
- Check rotor condition and minimum thickness. If necessary, replace the rotor.
- Check for the quality of the spare parts used.

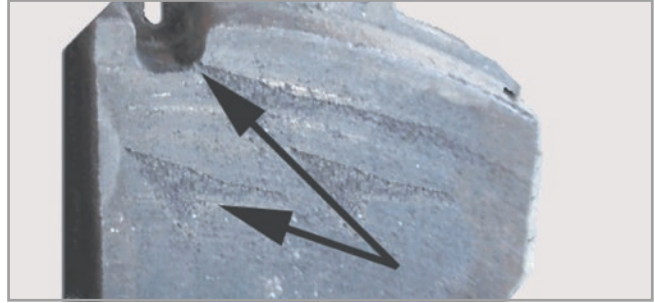
**APPEARANCE** Excessively worn out rotors and pads.

**CAUSE** Possible contamination of the friction material by sand, mud or earth or incomplete return of the caliper gear.

**EFFECT** Excessive wear of one or more brake pads, resulting in damage where the pad has not been fitted with a wear indicator.

- Replace the pads.
- Check rotor condition and minimum thickness.
- If necessary, replace both rotors on the axle.

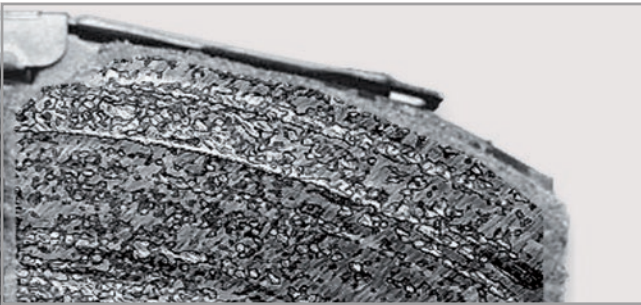
**APPEARANCE** Contaminated pad friction material.

**CAUSE** Contamination by an oily substance or solvent.

**EFFECT** Reduction in braking performance and possible imbalance during braking.

- Replace the pads.
- Check the rotors on the axle.
- Identify any fluid leaks from the hubs or other nearby components.

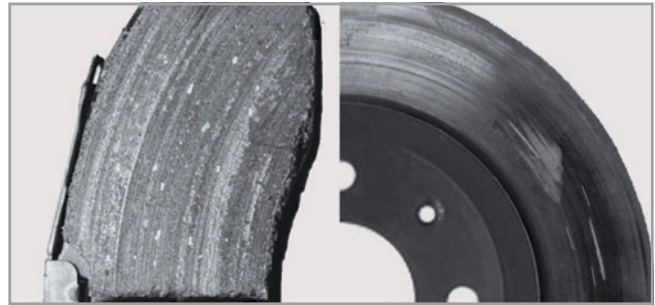
**APPEARANCE** Friction includes metal pick-up.

**CAUSE** High temperature generated between brake pad and rotor in wet conditions.

**EFFECT** Wear of the affected brake rotor with typical metal rubbing noise during braking.

- Replace the pads.
- Check rotor condition and minimum thickness.
- If necessary, replace both rotors on the axle.

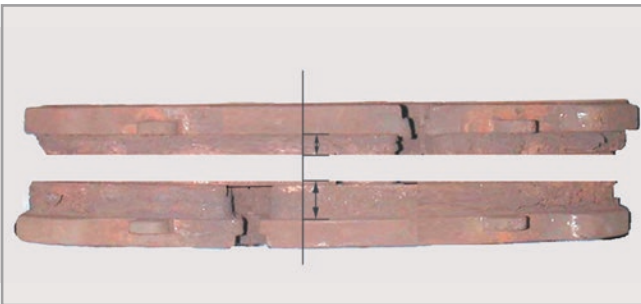
**APPEARANCE** Uneven brake pad wear.

**CAUSE** One of the calipers has become stuck or does not return correctly to the rest position.

**EFFECT** Reduction in braking performance and possible imbalance on the involved axle, during braking.

- Replace the pads.
- Brake calipers should be checked.

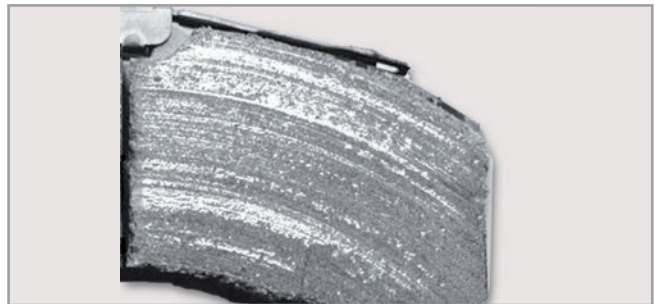
**APPEARANCE** Glazed pad friction material.

**CAUSE** Very low duty applied on the brakes, i.e. brake applications with low speed and low pressure.

**EFFECT** Reduction in braking performance and typical noise (squeal) while braking.

- If glazing is not too heavy can try to recondition the surface by some mileage of medium/hard brake duty, otherwise replace the pads.
- Check the rotor condition and minimum thickness.

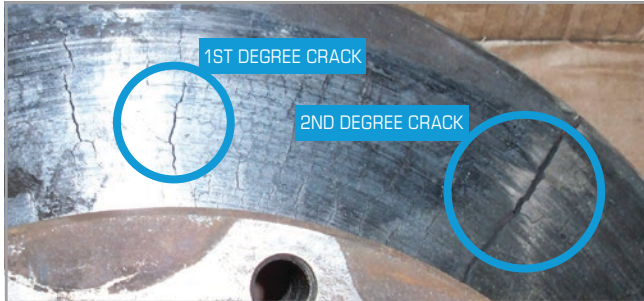
**APPEARANCE** Rotor surface features 1st and 2nd degree crack.

**CAUSE** Too intensive use of brakes due to the track features or to the carried load.

**EFFECT** Possible unexpected rotor mechanical collapse, particularly with 2nd degree crack.

- Immediate replacement of brake rotors and pads, particularly with 2nd degree crack, when one of the cracks is travelling from OD to ID.
- Brake calipers should be checked.

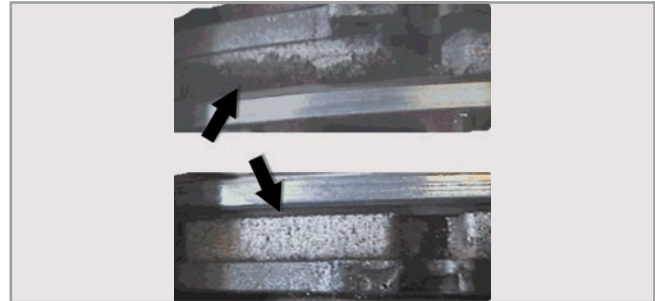
**APPEARANCE** Damaged edges to the friction material (edge-crumbling).

**CAUSE** Brake pad has become stuck in the caliper. The parts used do not comply with the correct sizes and specifications.

**EFFECT** Early pad deterioration and uneven rotor wear.

- Replace the pads.
- Check for correct caliper operation.
- Check rotor condition and minimum thickness.
- If necessary, replace both rotors on the axle.

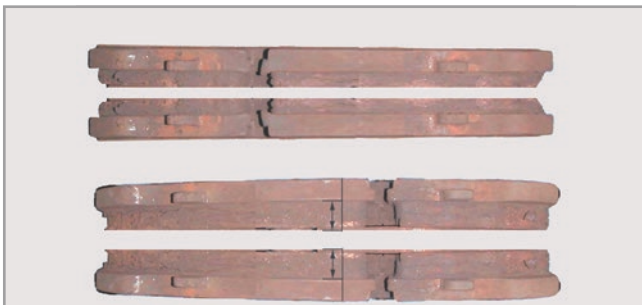
**APPEARANCE** Pads on the same axle featuring uneven wear.

**CAUSE** Incorrect return of one caliper on the same axle.

**EFFECT** If the axle involved is the directional one, this fault may result in vehicle instability during brake release.

- Replace the pads.
- Check for the proper caliper operation.
- Check rotor condition and minimum thickness.
- If necessary, replace both rotors on the axle.

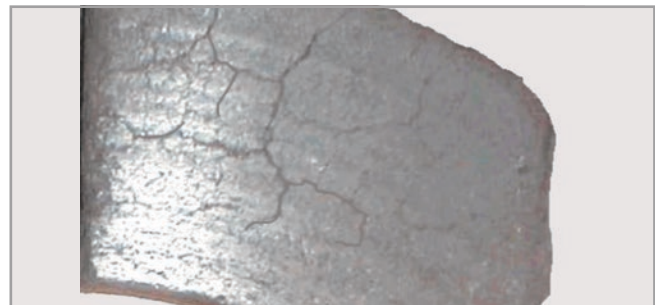
**APPEARANCE** Pad with surface cracks.

**CAUSE** Excessive load or high friction material temperature.

**EFFECT** Possible detachment of friction material resulting in a reduction in braking performance.

- Replace the pads.
- Check for correct caliper operation.
- Check rotor condition and minimum thickness.
- If necessary, replace both rotors on the axle.

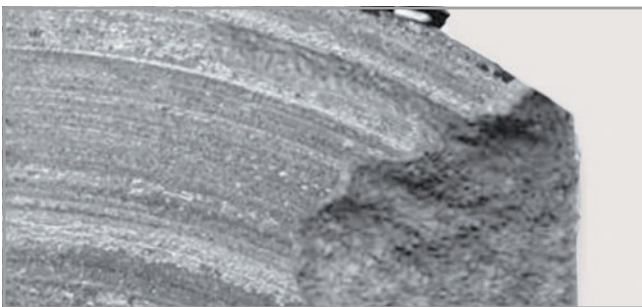
**APPEARANCE** Detached friction material.

**CAUSE** Possible excessive load or heavy braking, along with the choice of unsuitable parts.

**EFFECT** Reduction in braking performance and typical noise (squeal) while braking.

- Replace the pads.
- Check the rotor condition and minimum thickness.
- Despite having a wear indicator, it is necessary to check the pad condition during normal brake inspection and/or every six months.

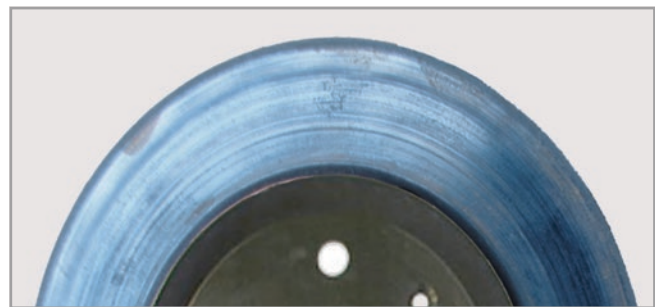
**APPEARANCE** Blue stripes on the rotor indicating a physical change due to overheating.

**CAUSE** Intensive use of brakes for prolonged braking or improper downhill braking.

**EFFECT** Brake rotor overheating which may result in contact surface distortion and cracks.

- Immediate replacement of brake rotors and pads.
- During the first 150 miles after replacement, sharp braking should be avoided in order to allow for the correct bedding-in of the newly fitted components.
