EASY SOLUTIONS BULLETIN

New dust boot design increases durability and eliminates premature wear

BMW

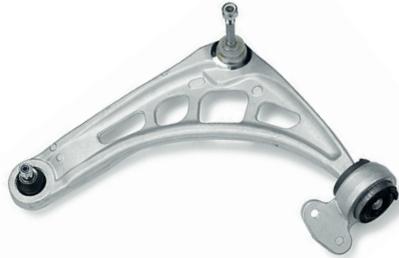
- Exposed metal surface.
- At full angle oscillation dust boot makes contact with the housing.

In order to avoid damage to the dust boot, **the boot was reshaped** so that it can no longer come into contact with the surrounding items, even at its maximum oscillation angle. In addition, **a rubber surface has been added to the upper ring** thus ensuring an improved sealing performance. This will maintain maximum longevity of the ball joint and wishbone.

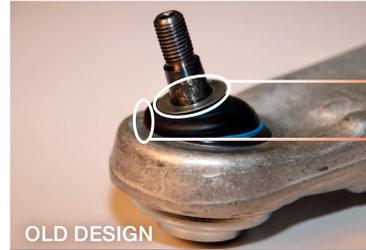
In some cases the dust boot becomes **worn and damaged due to contact with surrounding items**, such as, the upper ring and the housing, and subsequently moisture is able to enter in to the ball joint causing premature failure of the joint.

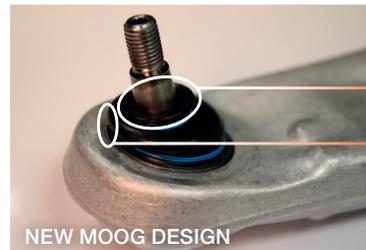
- Rubber surface on the sealing ring.
- No contact with dust boot, even at the maximum oscillation angle.
