4 GAS ANALYSER TEST : CORRECT GAS VALUES FOR VEHICLES EQUIPPED WITH CATALYTIC CONVERTER SYSTEMS

DIAGNOSIS OF THE CATALYTIC CONVERTER

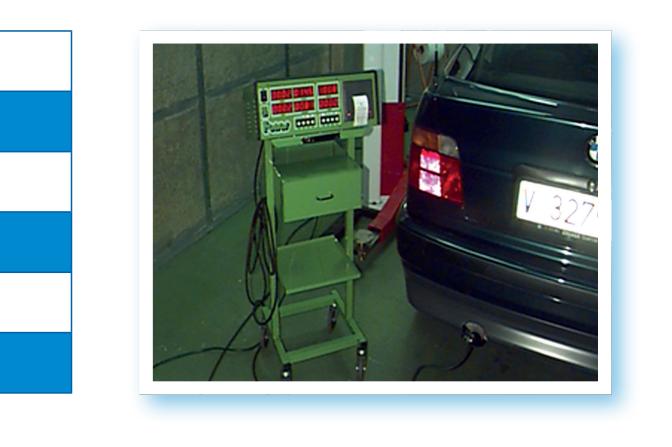
FAILURE OF THE CATALYTIC CONVERTER DUE TO NATURAL WEAR OF THE UNIT

- Throughout the vehicle's life, due to usage, a fine layer of combustion residues is deposited on the surface of the precious metals, reducing the capacity of the catalytic converter to transform the harmful gasses before they are released into the atmosphere. When this happens, the catalytic converter must be replaced by a new unit.
- It is considered that the useful life of a catalytic converter is of some 100.000 to 140.000 km. The lifetime of the catalytic converter will depend on various factors such as the quality of the fuel being used, the way in which the vehicle is driven, the frequency and quality of the maintenance of the vehicle, etc.
- Walker[®] recommend to check the emission control system every 20.000 km or once a year in order to determine the condition of the catalytic converter and all the elements linked to this important system.

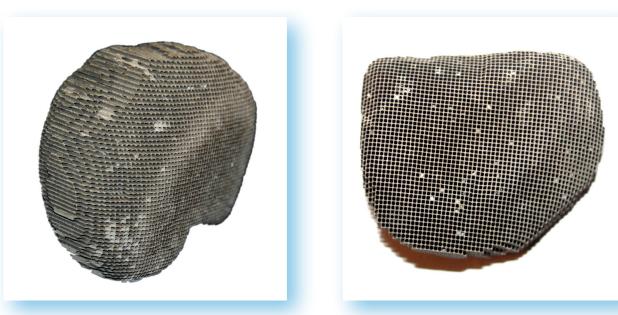
MELTED MONOLITH DUE TO THE COMBUSTION OF UNBURNED FUEL (HC) **INSIDE THE CATALYTIC CONVERTER**

When high amounts of unburned hydrocarbons (HC) exit the combustion chambers along with the exhaust gases and come in to contact with the surface of the monolith, which in normal working conditions is over 450°C, the fuel auto-ignites and increases the temperature up to 1850°C, causing a rapid and continuous fusion of the monolith which generally leads to the total destruction of the catalytic converter. These failures generally occur because of ignition or intake problems (Wrong air/fuel ratio in the cylinders).
