H1134CPA PISTONS

Problem Solving Solution for 04-07 GM Big Block 8.1L Engines

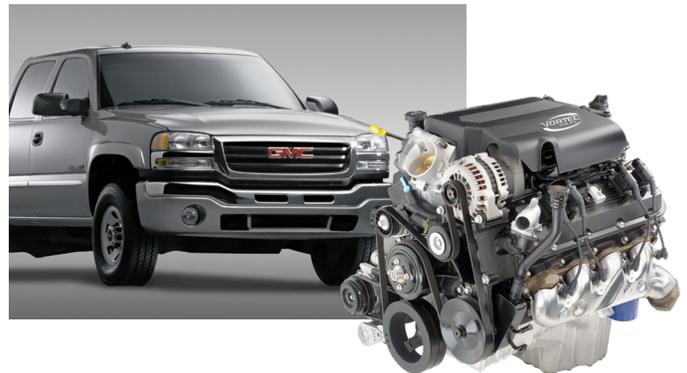
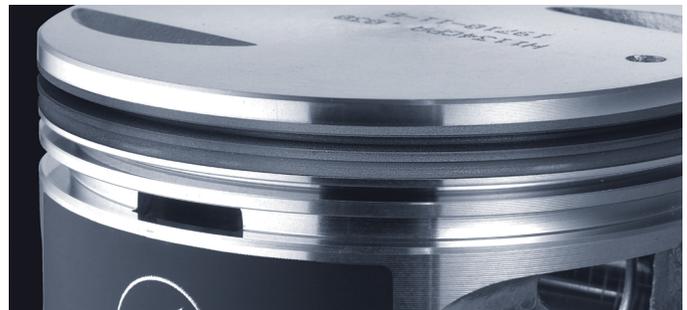
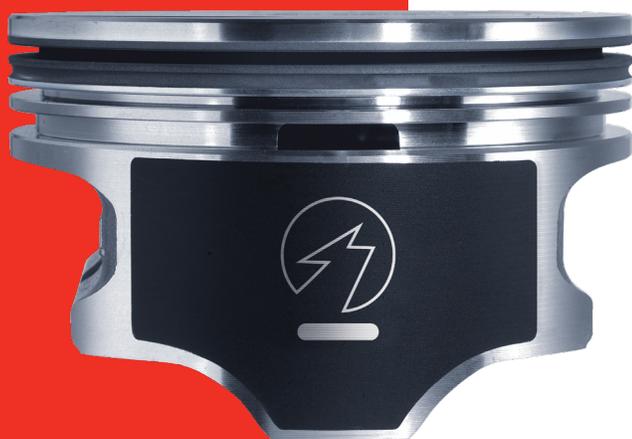
SOLUTION: SEALED POWER HARD-ANODIZED TOP RING GROOVE

In engines exhibiting these high temperature conditions and a propensity to micro-welding, our engineers require hard-anodizing for the top ring groove and a taller top land. The taller top land moves the ring into a slightly cooler zone while hard-anodizing in the groove further combats micro-welding. The result is a superior high-quality piston with what it takes to live in these high-output engines.
