TECBLOG **SEALING SUBARU 2.5L ENGINES**

THE EJ-SERIES 2.5L BOXER ENGINE HAS BEEN POWERING MANY OF SUBARU'S VEHICLES SINCE 1996. THERE ARE MANY DIFFERENT VARIATIONS OF THIS MOTOR, AND THEY ALL SHARE THE POTENTIAL FOR DEVELOPING HEAD GASKET LEAKS.

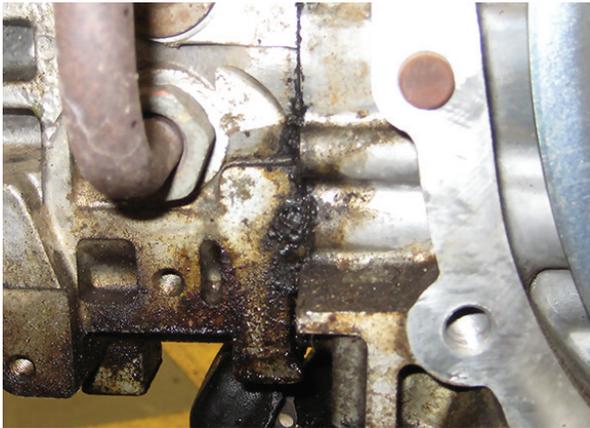
The OE gaskets' composite and early-generation MLS gaskets are both prone to leaks. Earlier gaskets tended to leak combustion gasses or coolant internally, often resulting in an oily residue or smell in the coolant overflow bottle and subsequent coolant loss and overheating. Later gaskets tend to develop external coolant and/or oil leaks, which are initially noticed by the smell of oil or coolant burning and can be seen at the head gasket joint.

External oil leak from failed head gasket

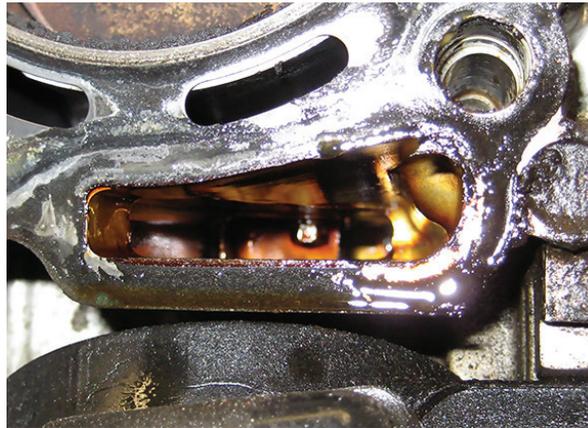
Head gasket damage, resulting in external leak

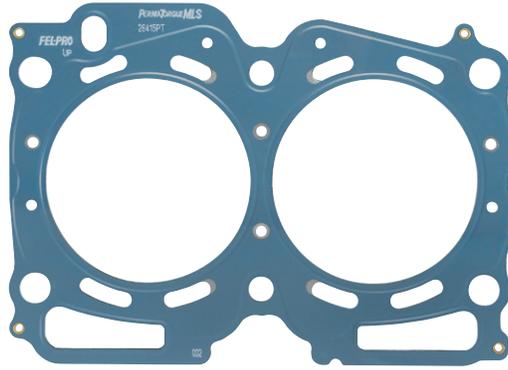
This solution starts with the proven PermaTorque® MLS gasket design. Each PermaTorque MLS gasket is designed on an application-specific basis, using multiple layers of full-hard stainless steel with embossed beads and specialized coatings. The sealing beads act as springs to maintain sealing strength through heat cycling and under extreme conditions. The coating negates the possibility for excessive scrubbing as the castings expand and contract. The coating also compensates for surface finishes as rough as 60 R_a, instead of the 30 R_a or smoother often required by OE MLS head gaskets.

On demanding applications like the Subaru 2.5L engine, Fel-Pro incorporates LaserWeld™, a laser-welded stopper layer added to further improve sealing. This technology was originally developed for use in stock car racing and has been proven to hold up to the most extreme conditions. The LaserWeld stopper layer precisely controls and limits the compression of the multiple layers within an MLS head gasket to ensure proper sealing stress. This stopper layer withstands cylinder pressures more than twice that of a standard MLS gasket. This further helps to promote extended head gasket life and allows the gasket to perform exceptionally well in engines with performance enhancements.

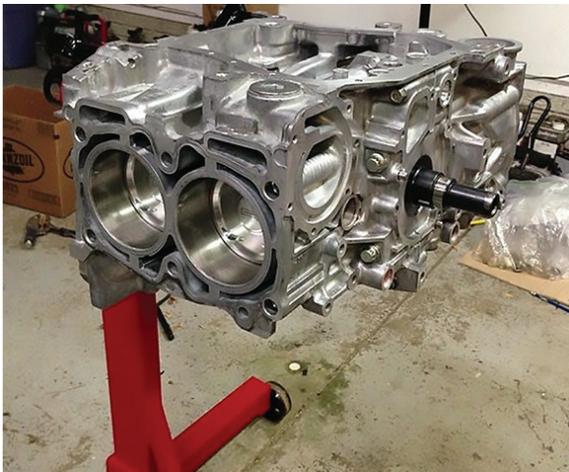
TORQUE SPECS

As with any engine that uses torque-to-yield head bolts, it is important to install new head bolts when servicing Subaru 2.5L head gaskets to ensure proper bolt loading, even though the OE repair manual doesn't call for new head bolts. Follow the correct torquing sequence and specifications when installing.
