# SERVICEGRAM

### Air Suspension Issues

**Application: 2013-2018 Ram 1500**

### Monroe® Suspension Conversion Kits

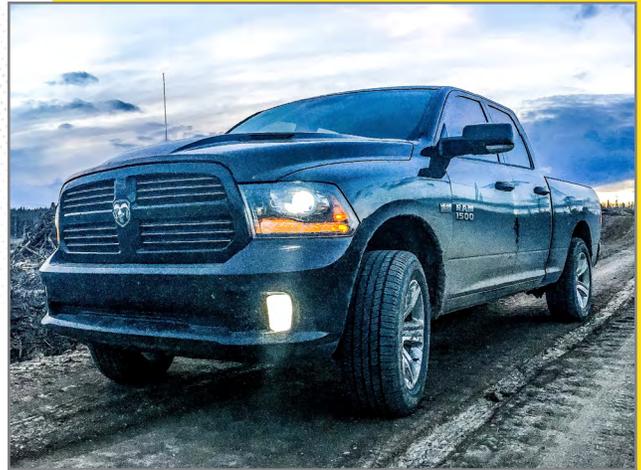
The owners of Ram 1500 pickups love their trucks' air suspension – in the summertime. Unfortunately, many of these truck owners have discovered that as temperatures drop, they may experience a ride height change and Malfunction Indicator Lamp (MIL) illumination. To view the Ram service bulletin, [click here](#).

Ram 1500 pictured is at normal ride height.

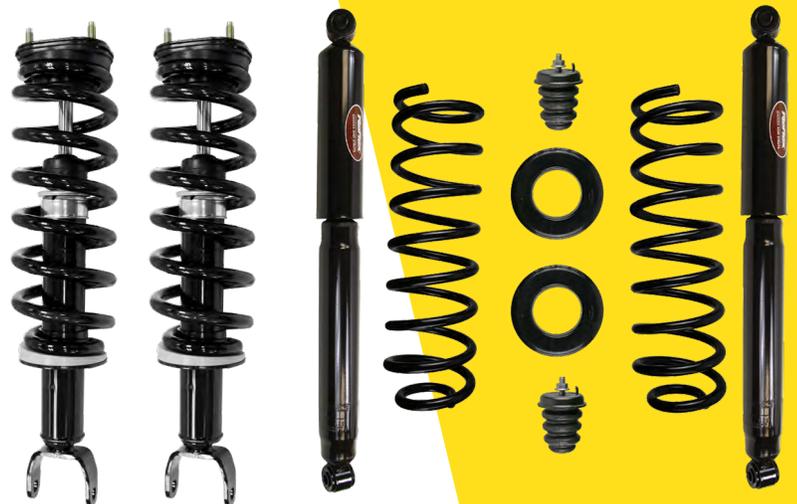
The new Monroe conversion kit covers the front-right, front-left and rear of 2013-2018 Ram 1500 trucks equipped with factory air suspensions. The new kit provides all of the components needed to help restore proper vehicle ride height and handling, including front strut assemblies, rear shock absorbers, rear coil springs, spring isolators and jounce bumpers.

Monroe offers a comprehensive, reliable solution for these vehicle owners: Monroe Suspension Conversion Kits that enable customers to save time and money by converting worn original equipment air suspensions to mechanical suspensions.

Monroe provides detailed, step-by-step instructions to help ensure an efficient, high-quality repair.
